THE GLADE

SKETCH REVIEW SUBMITTAL

200N 7TH AVENUE

OUTLET E-2, REPLAT A, RIVER PINES SUBDIVISION
TOWN OF FRISCO, SUMMIT COUNTY
COLORADO

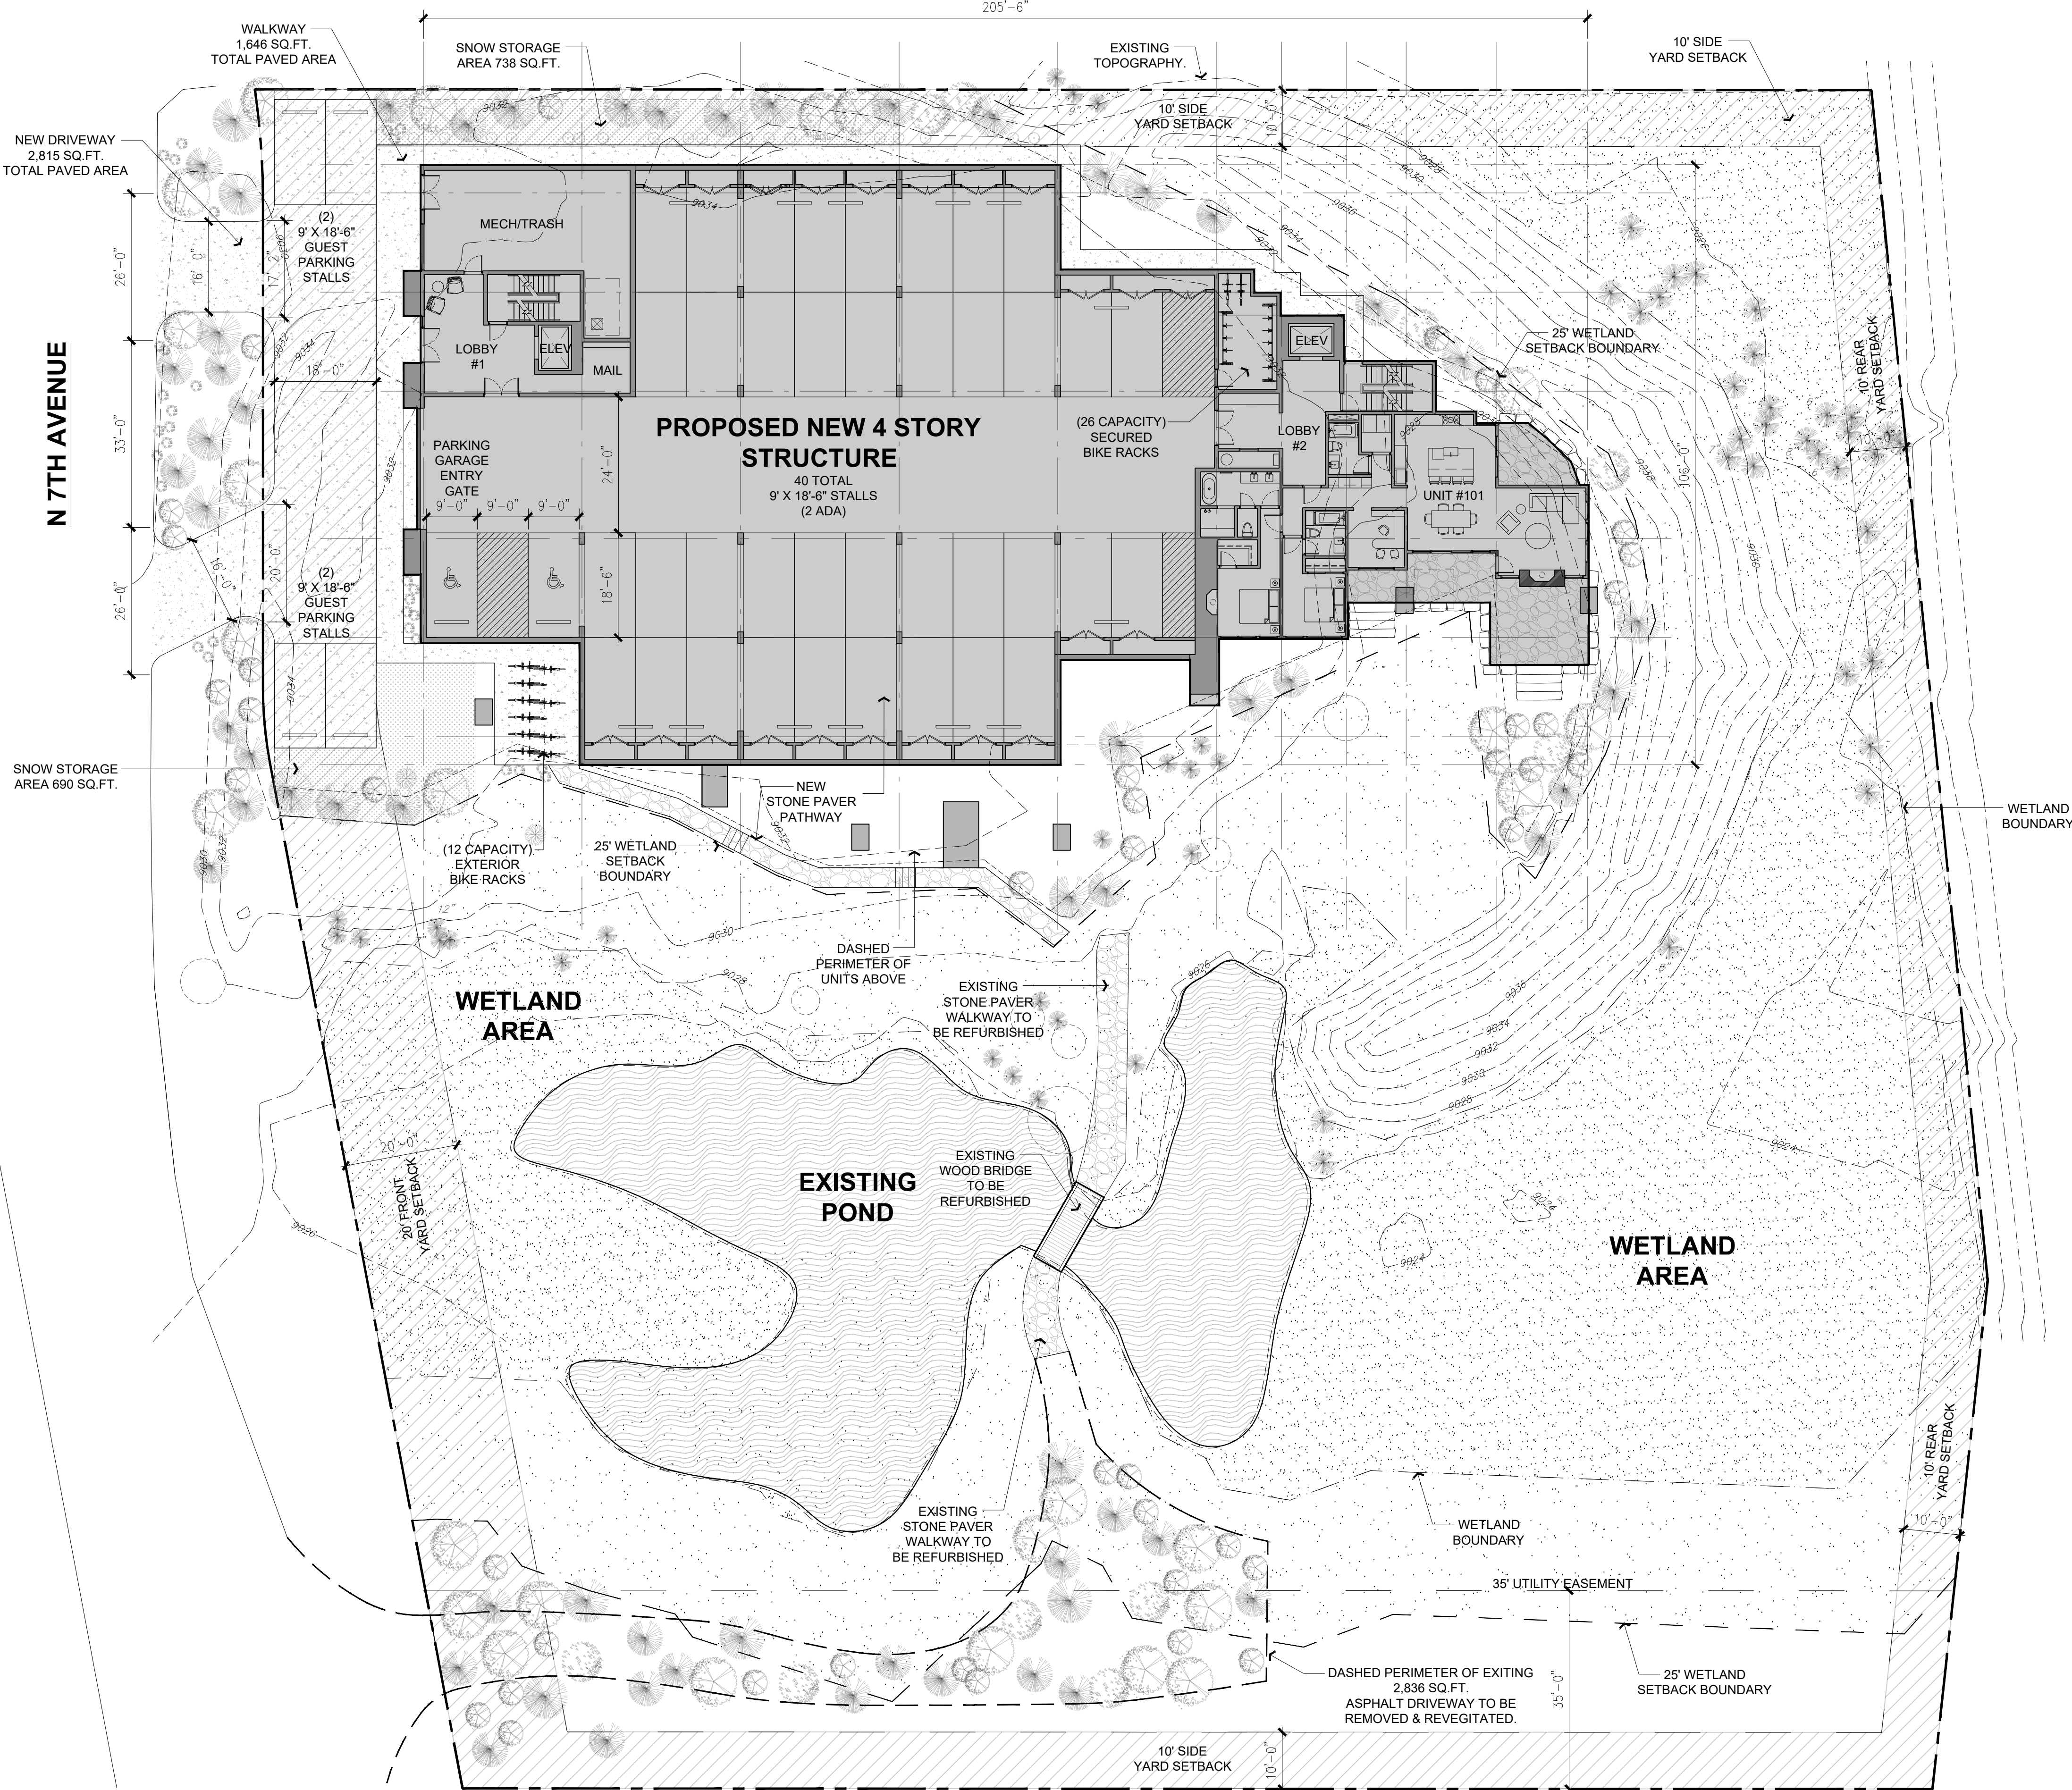
PAVED DRIVEWAY & GUEST PARKING AREA: 2,815 Q.FT.
PAVED WALKWAY AREA: 1,646 SQ.FT.

SNOW STORAGE AREA REQUIRED: 1,275 SQ.FT.
SNOW STORAGE AREA PROVIDED: 1,428 SQ.FT.

A NEW SITE PLAN
1/16" = 1'-0"

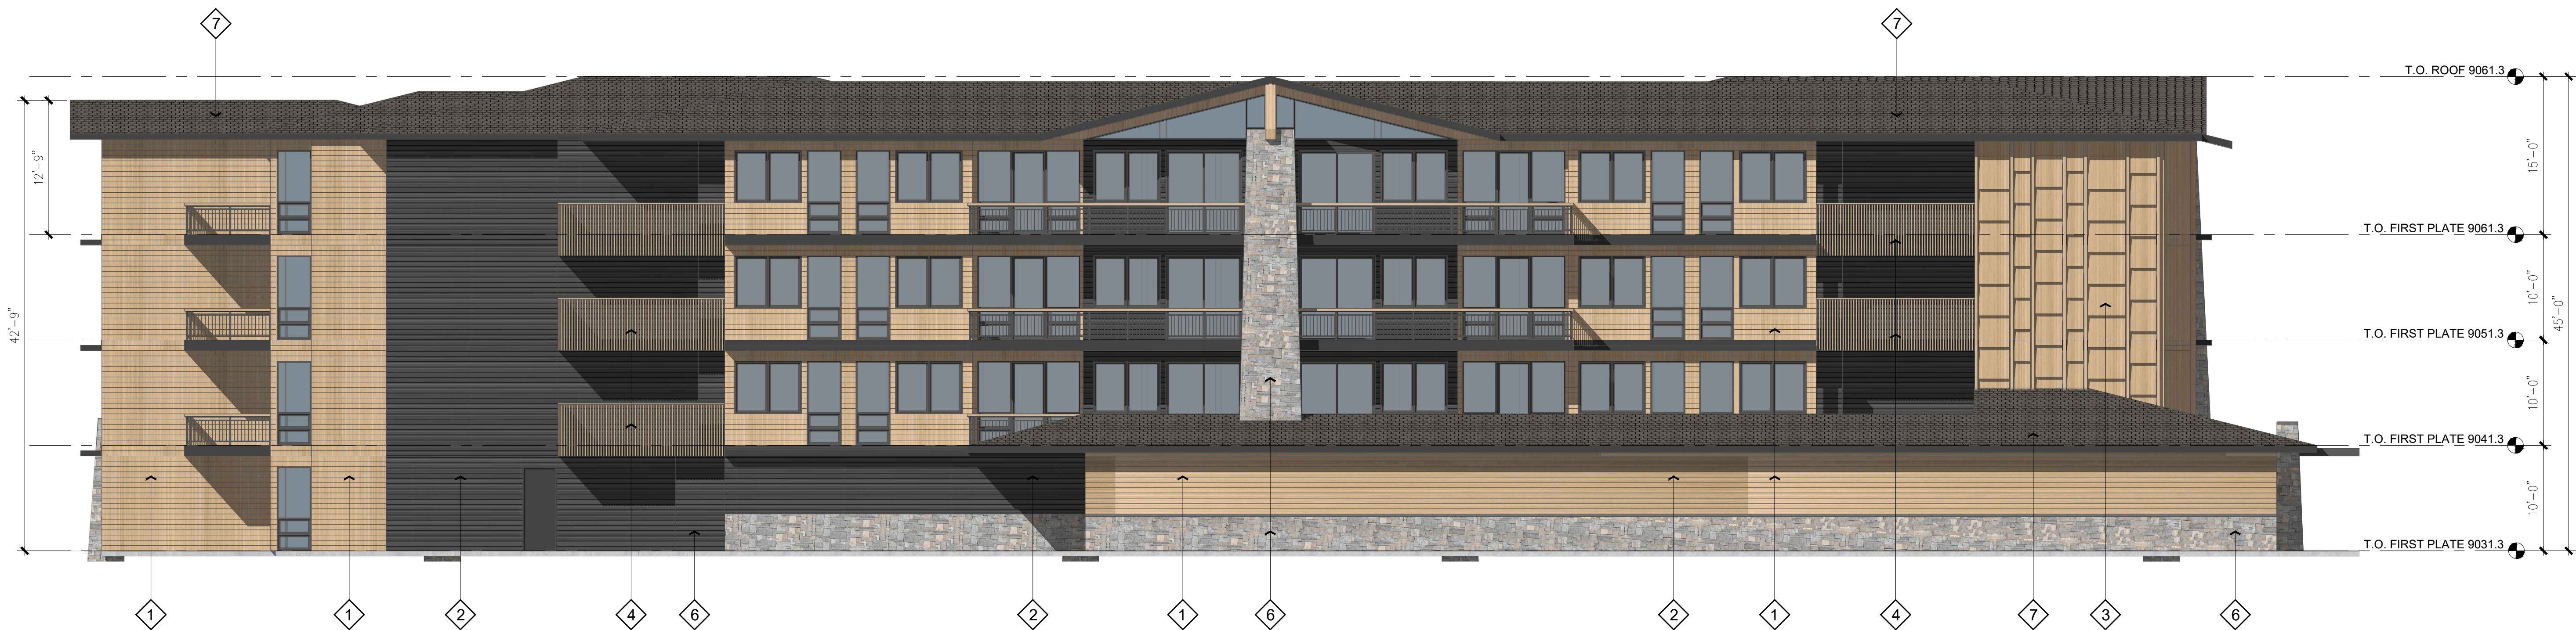
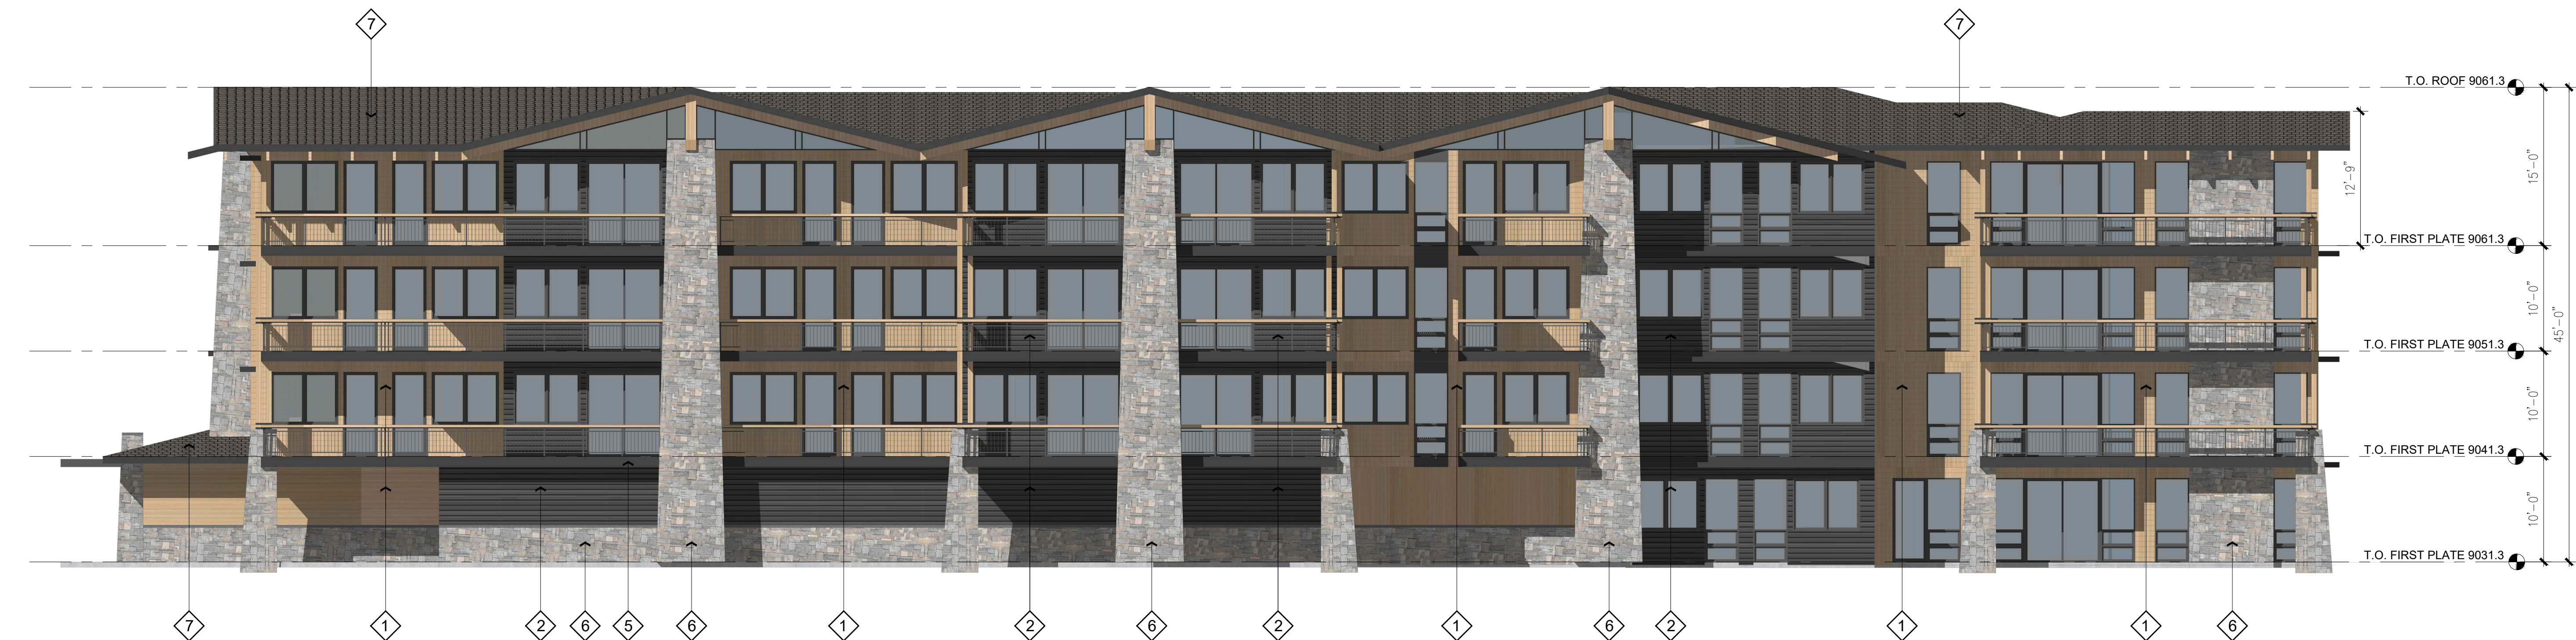
A NORTH ELEVATION
1/8" = 1'-0"

B SOUTH ELEVATION
1/8" = 1'-0"

1
CEDAR LAP SIDING
OLYMPIC SEMITRANSSPARENT
"NATURALTONE FIR 718"

Please see the material color board provided on Exterior Elevations in the submittal package. Wood, metal and stone siding will be utilized.

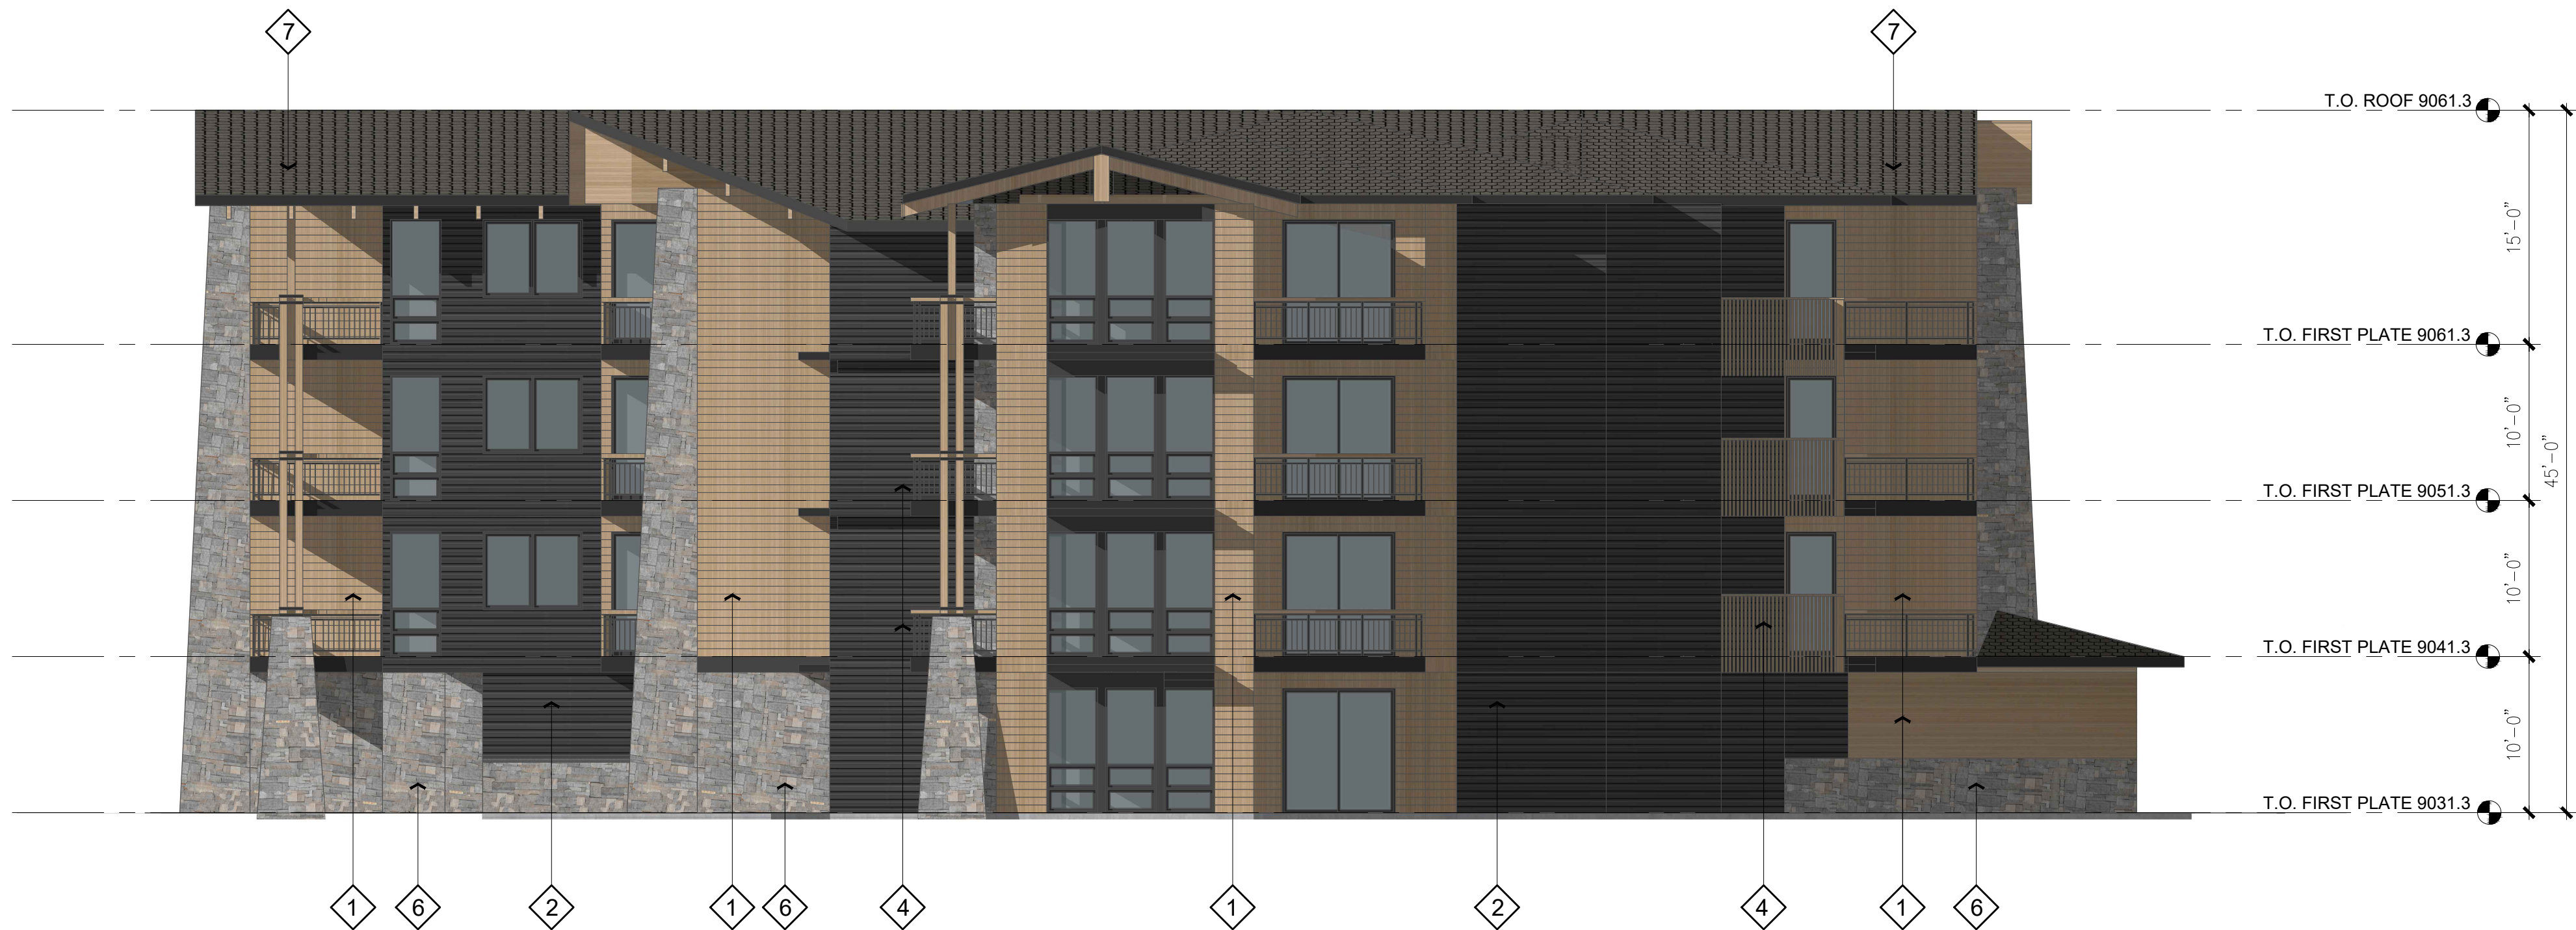
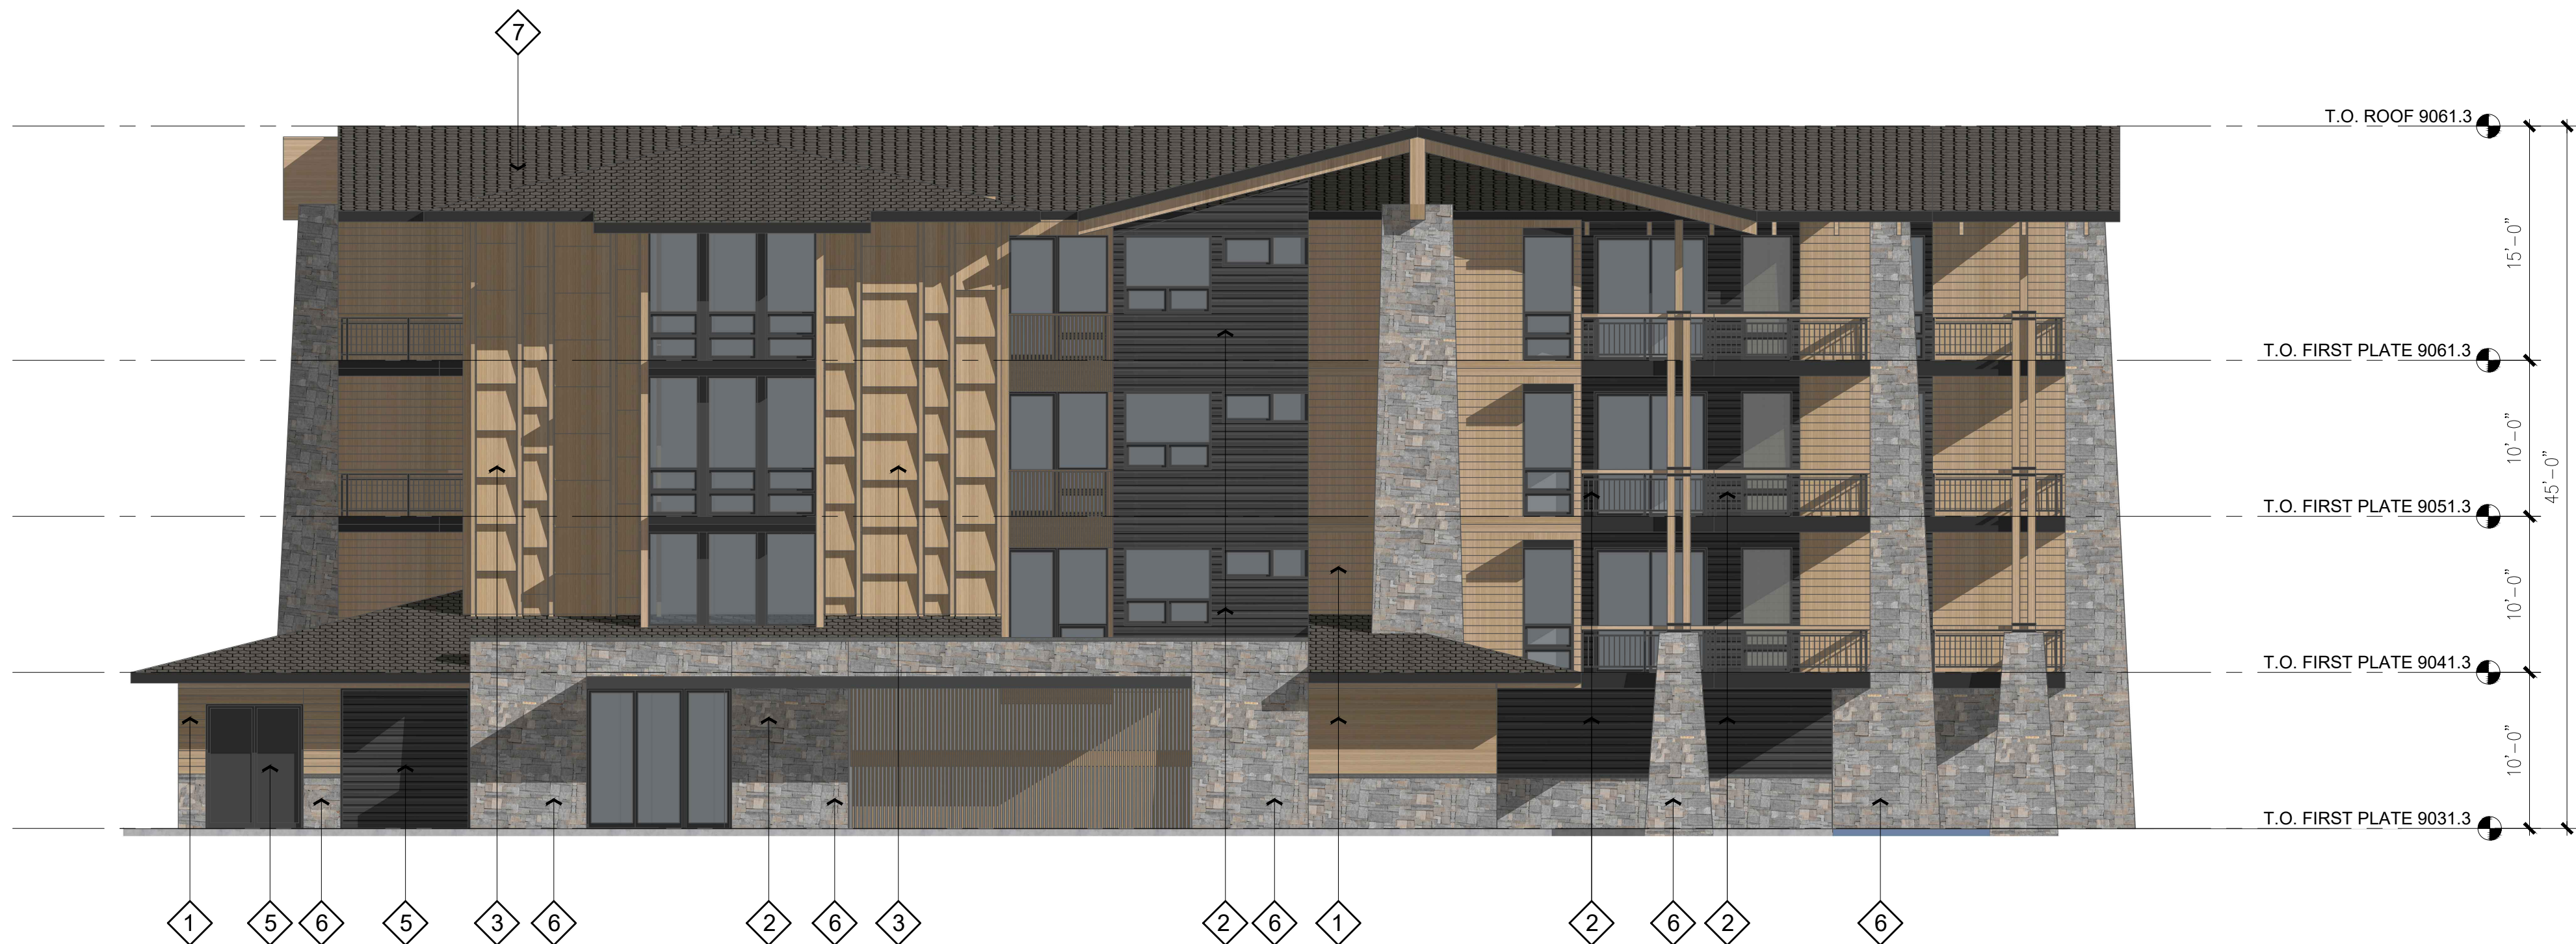
A EAST ELEVATION
1/8" = 1'-0"

B WEST ELEVATION
1/8" = 1'-0"

1
CEDAR LAP SIDING
OLYMPIC SEMITRANSSPARENT
"NATURALTONE FIR 718"

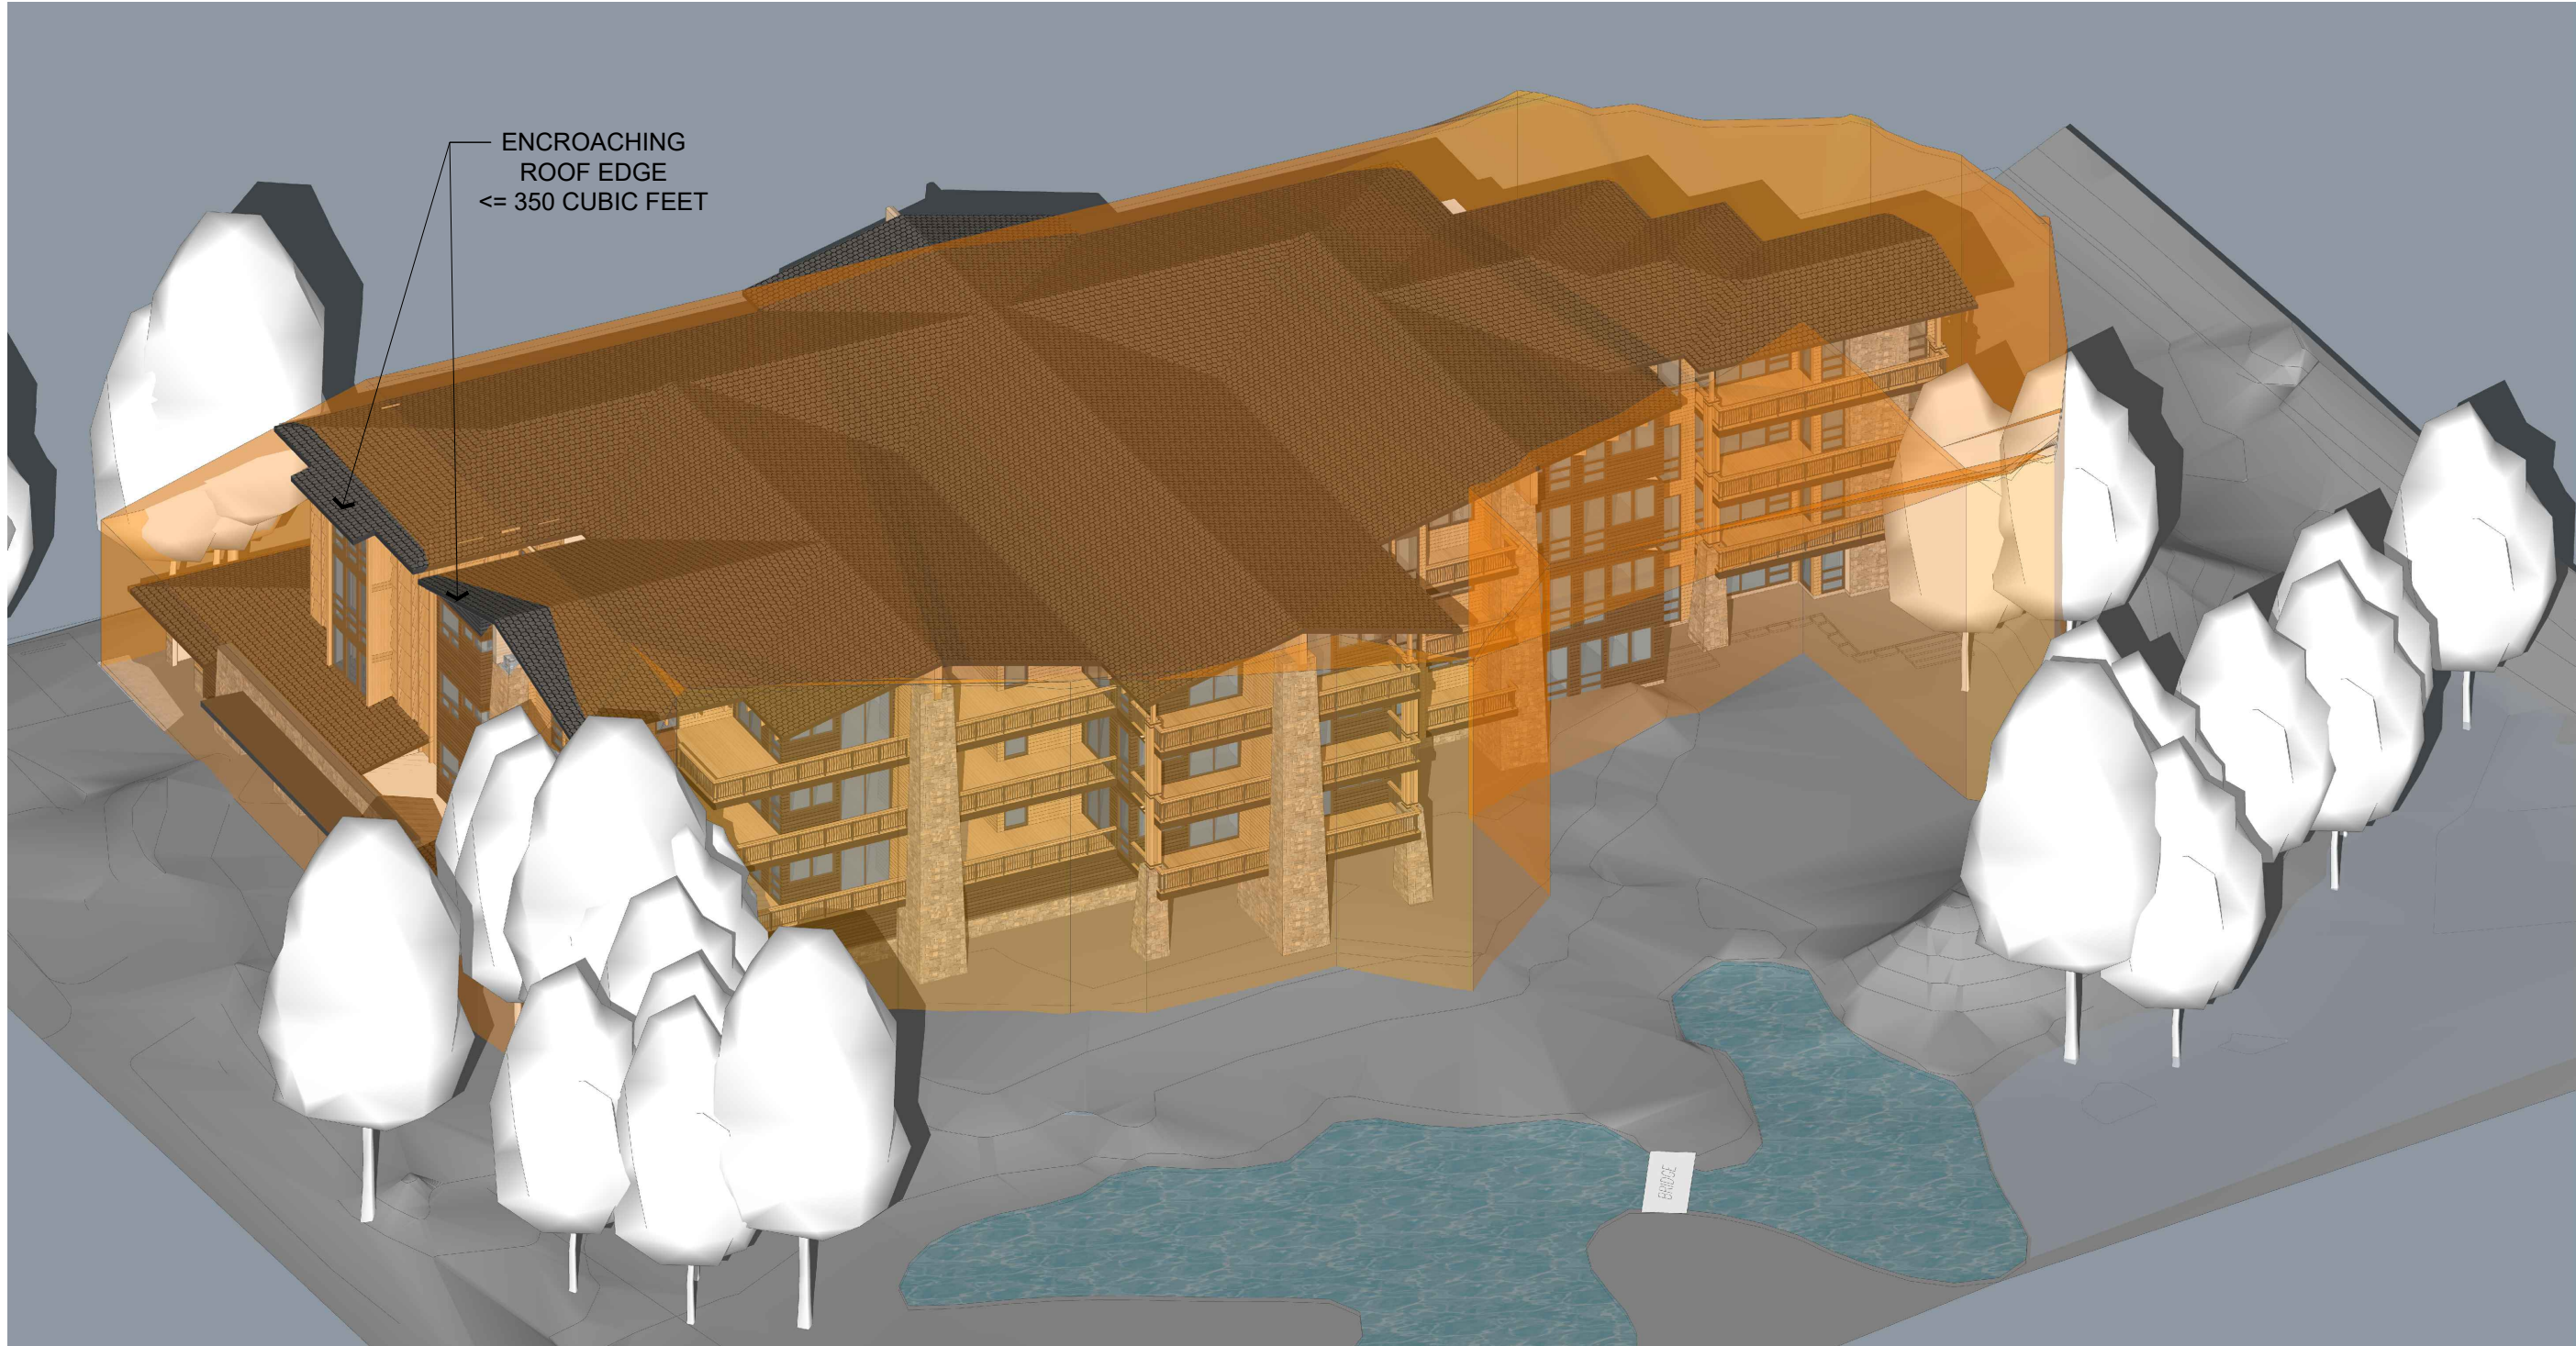
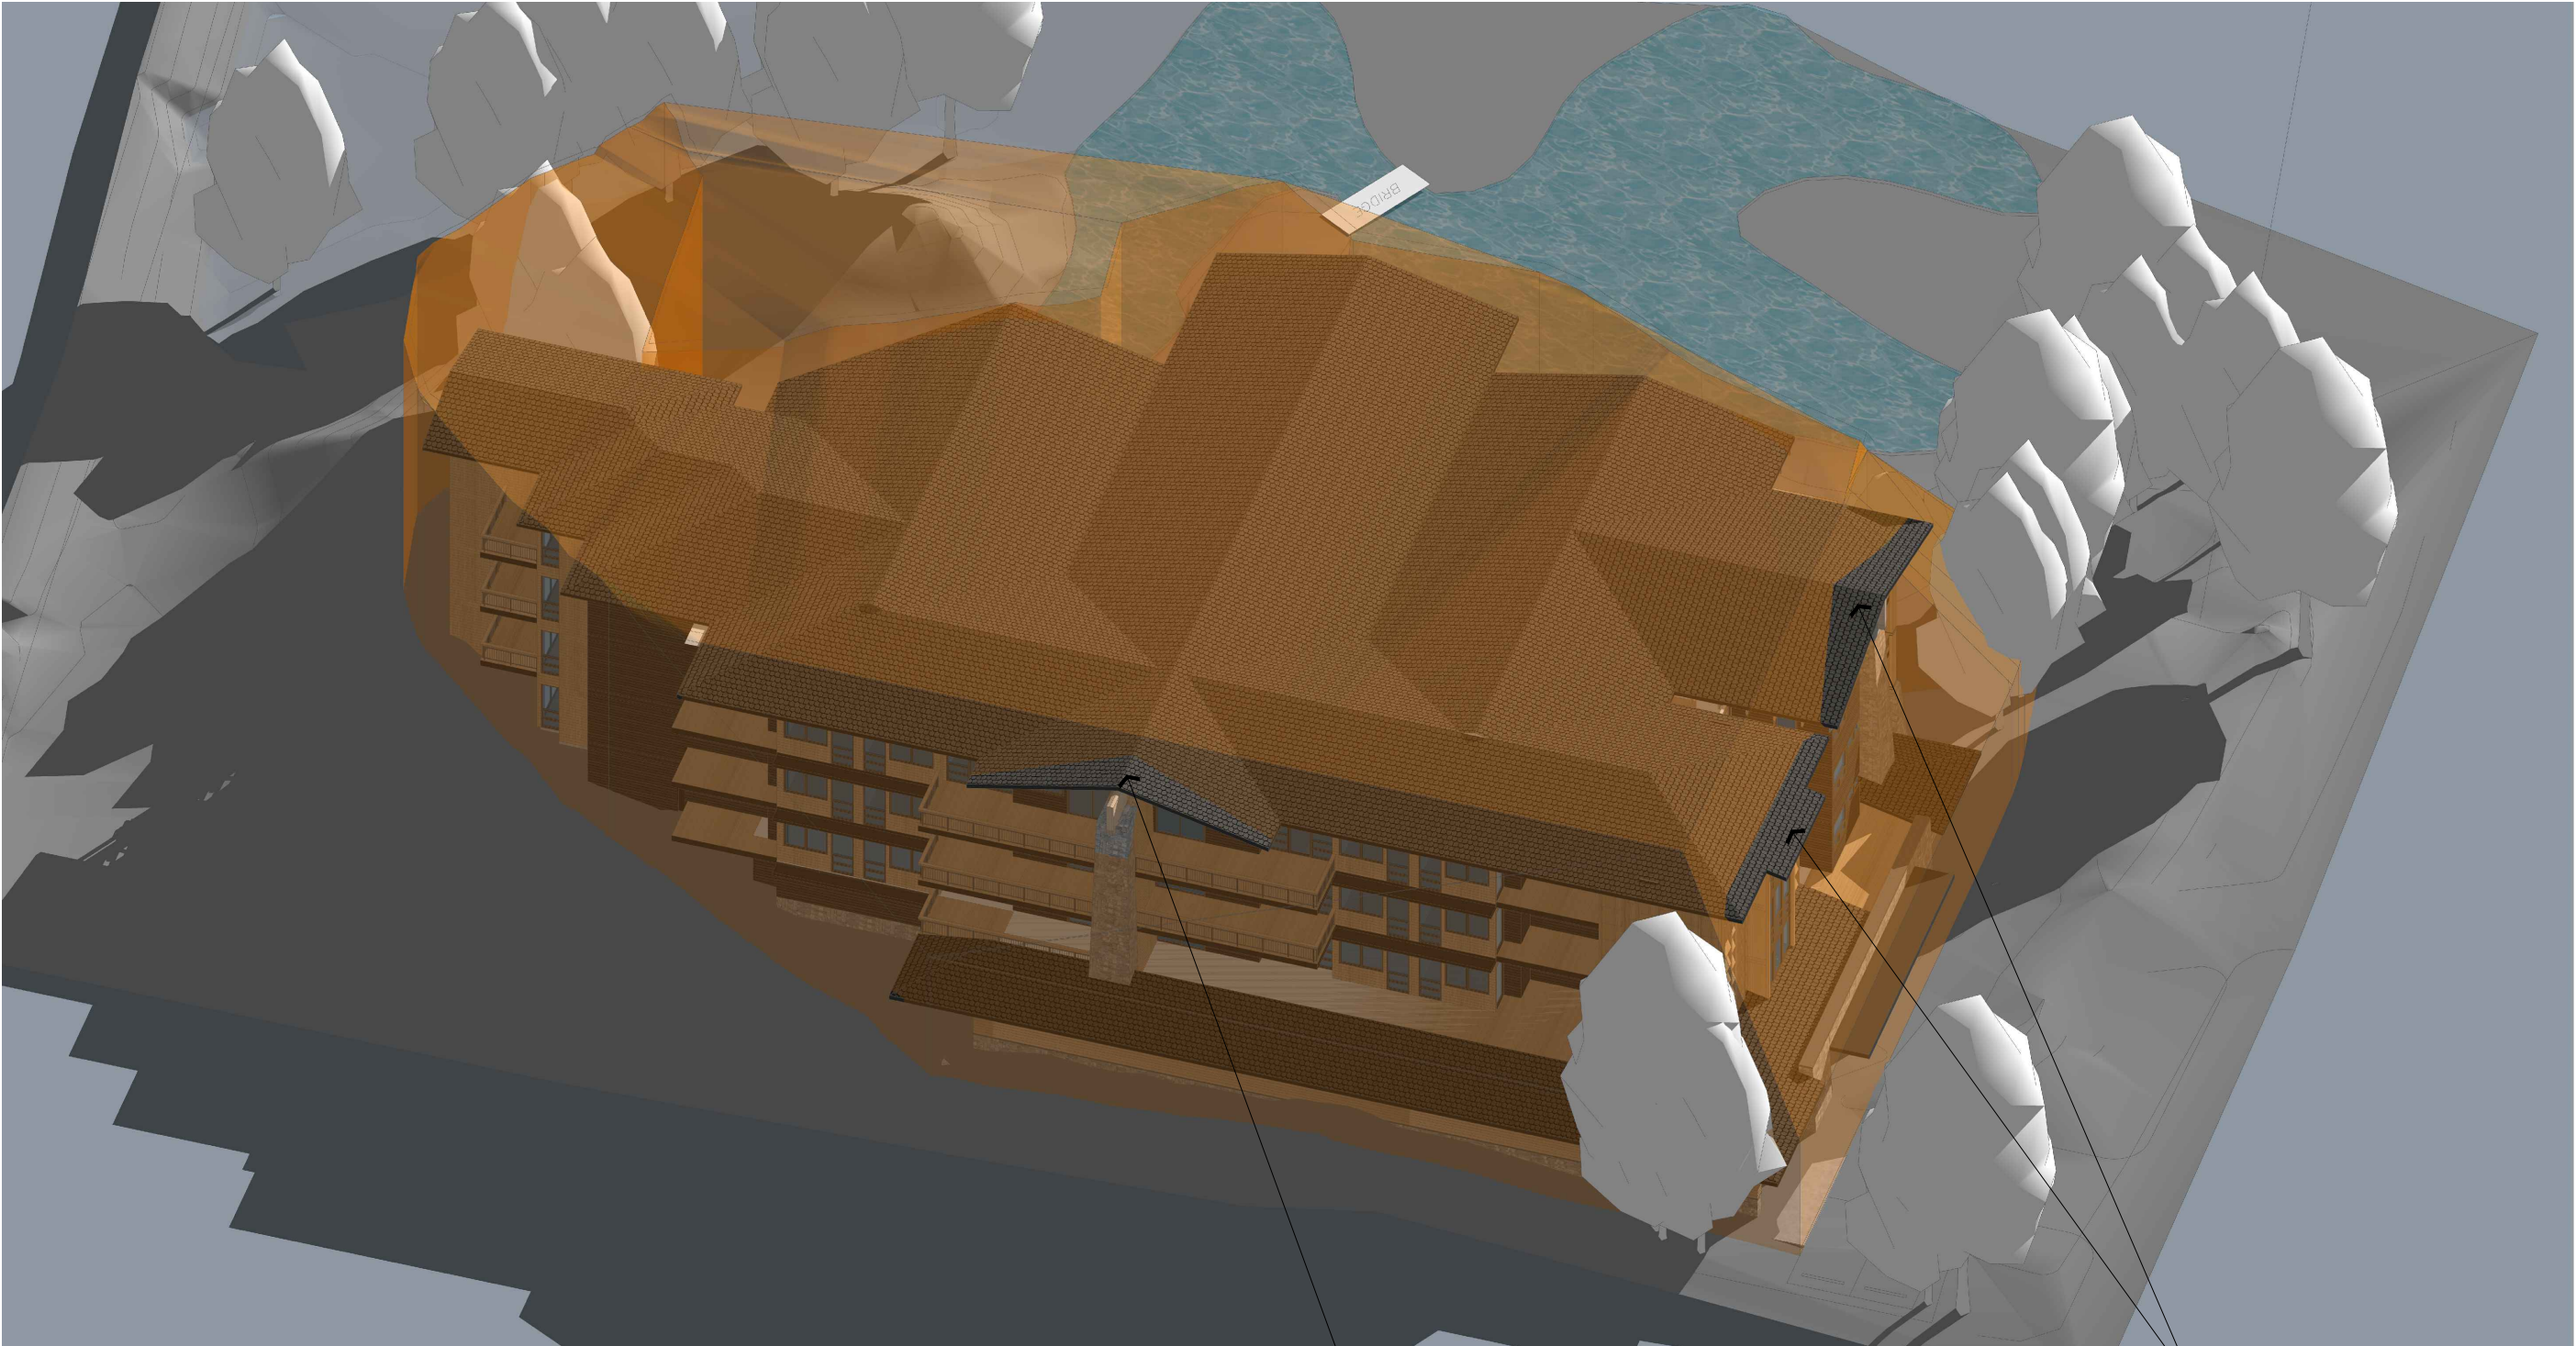
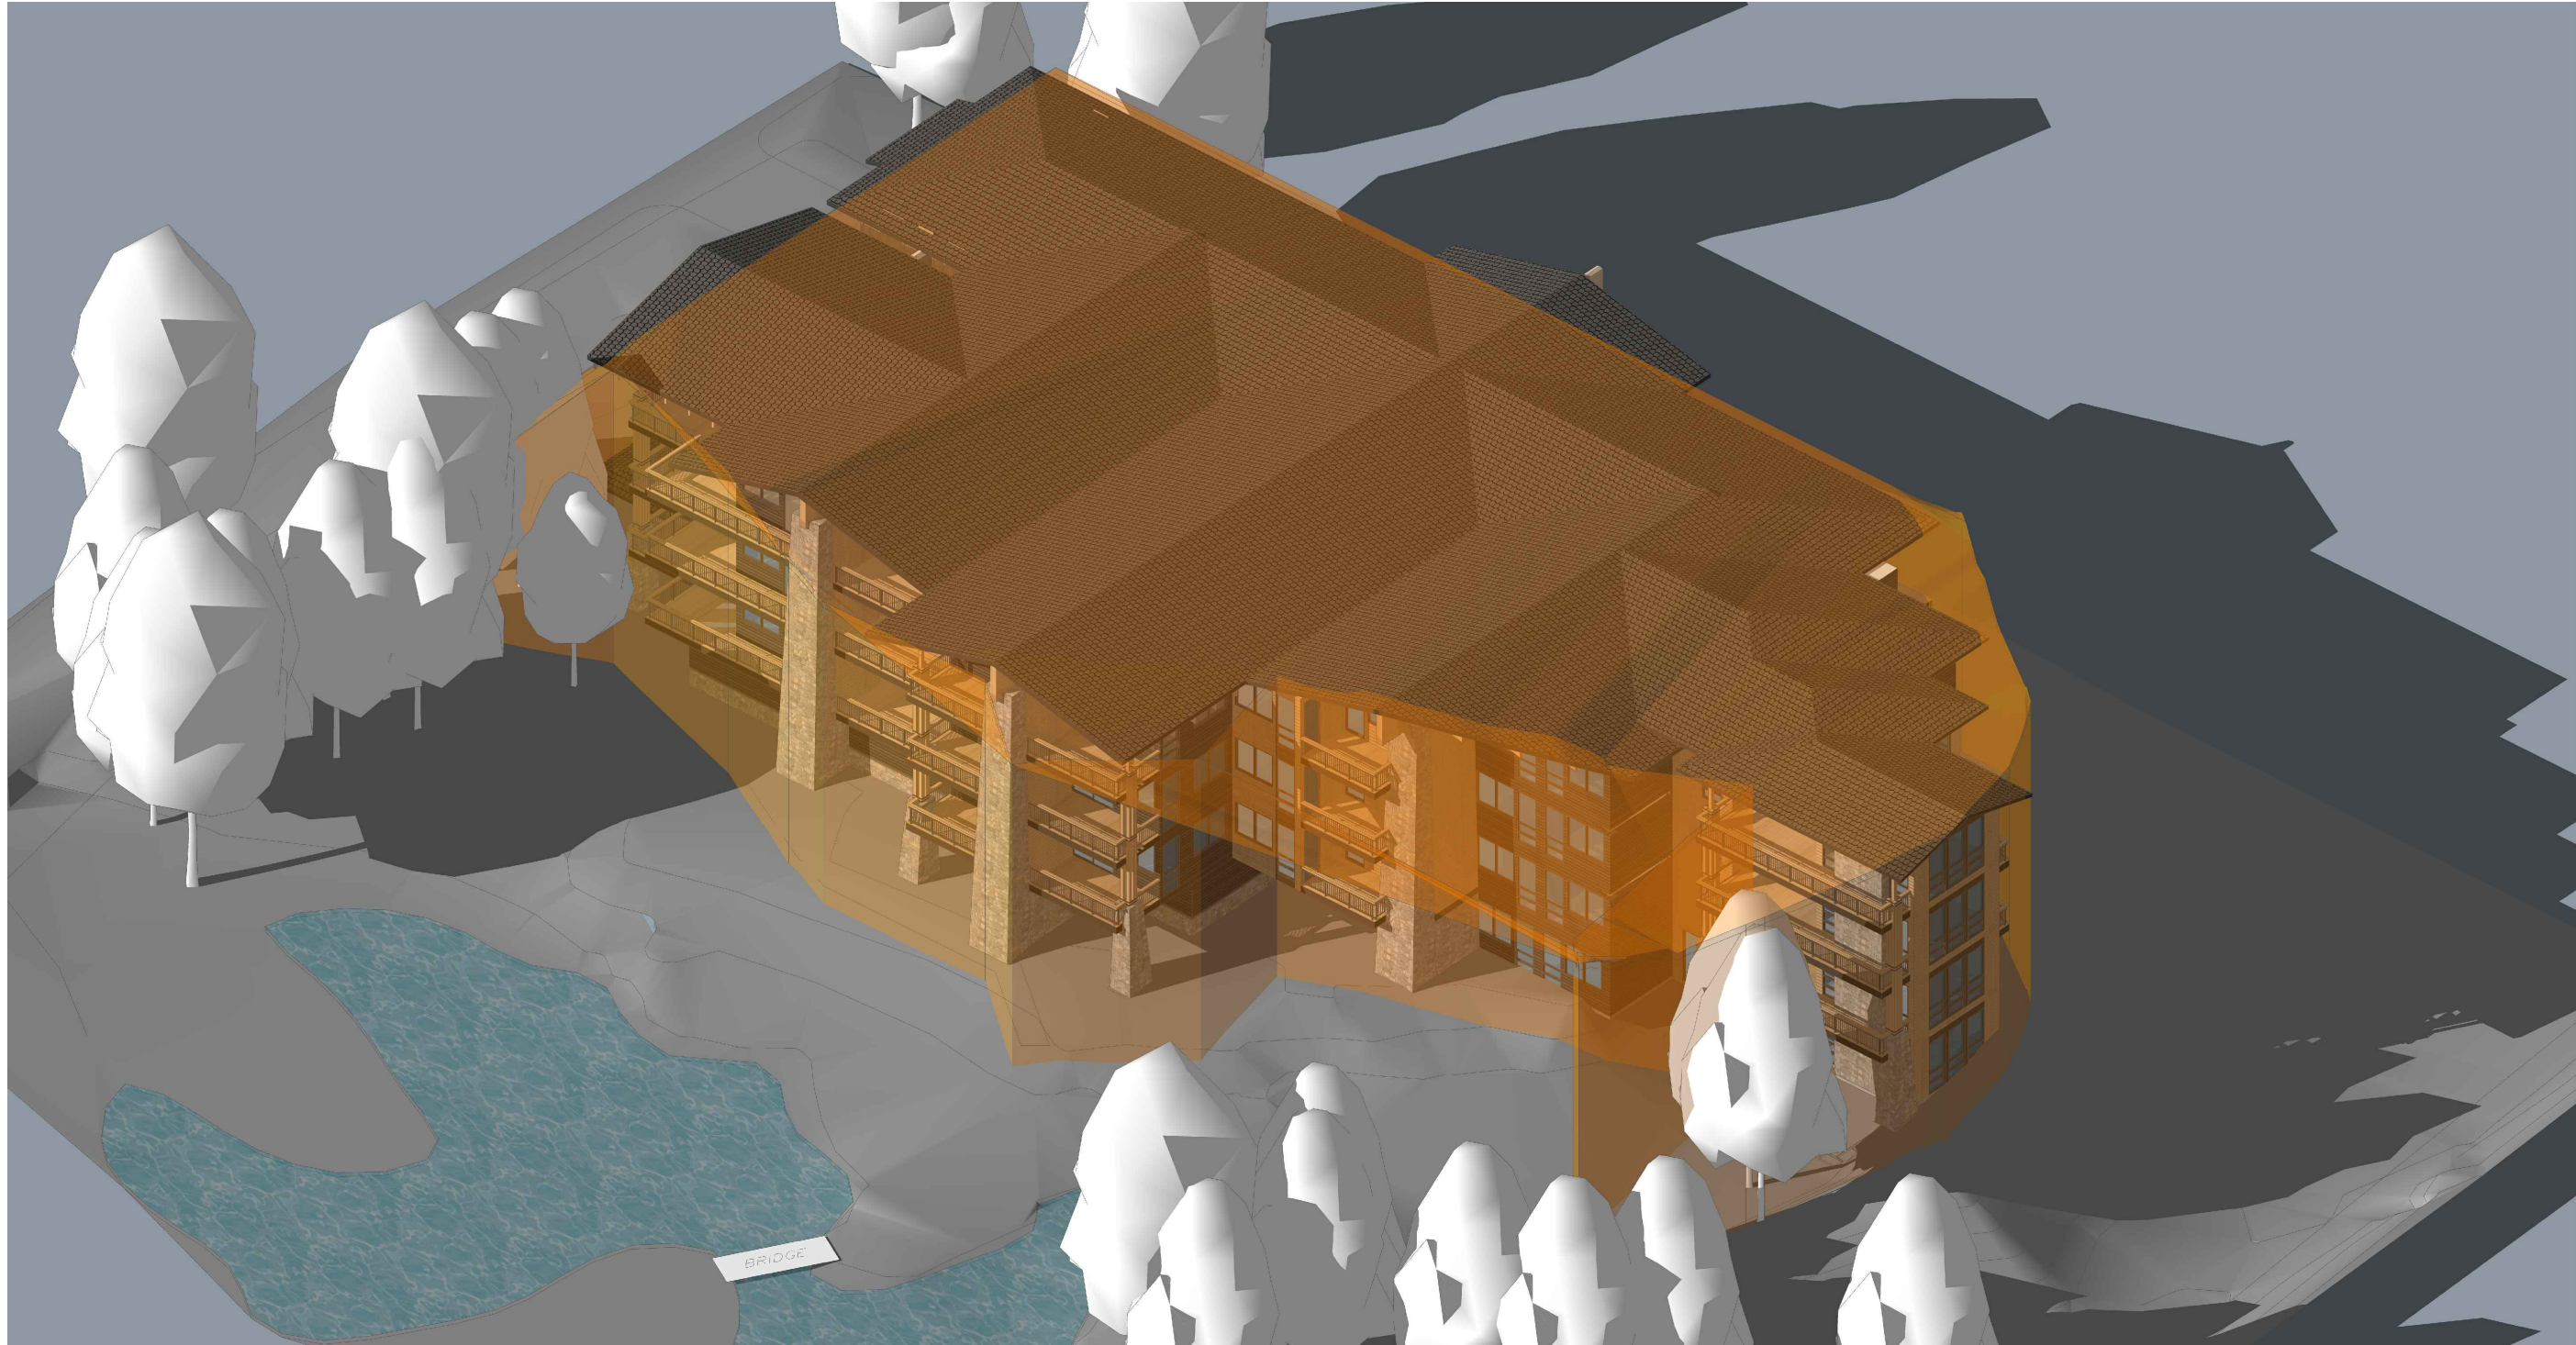
A BULK PLANE DIAGRAM
NOT TO SCALE

B BULK PLANE DIAGRAM
NOT TO SCALE

C BULK PLANE DIAGRAM
NOT TO SCALE

We are seeking an architectural bulk plane relief variance from the Planning Commission on the north and west sides of the property. There are minimal roof overhangs on the gables on the west and north sides and the total amount of encroachment does not exceed 350 cubic feet.
