THE GLADE

SKETCH REVIEW SUBMITTAL

200N 7TH AVENUE

OUTLET E-2, REPLAT A, RIVER PINES SUBDIVISION
TOWN OF FRISCO, SUMMIT COUNTY
COLORADO

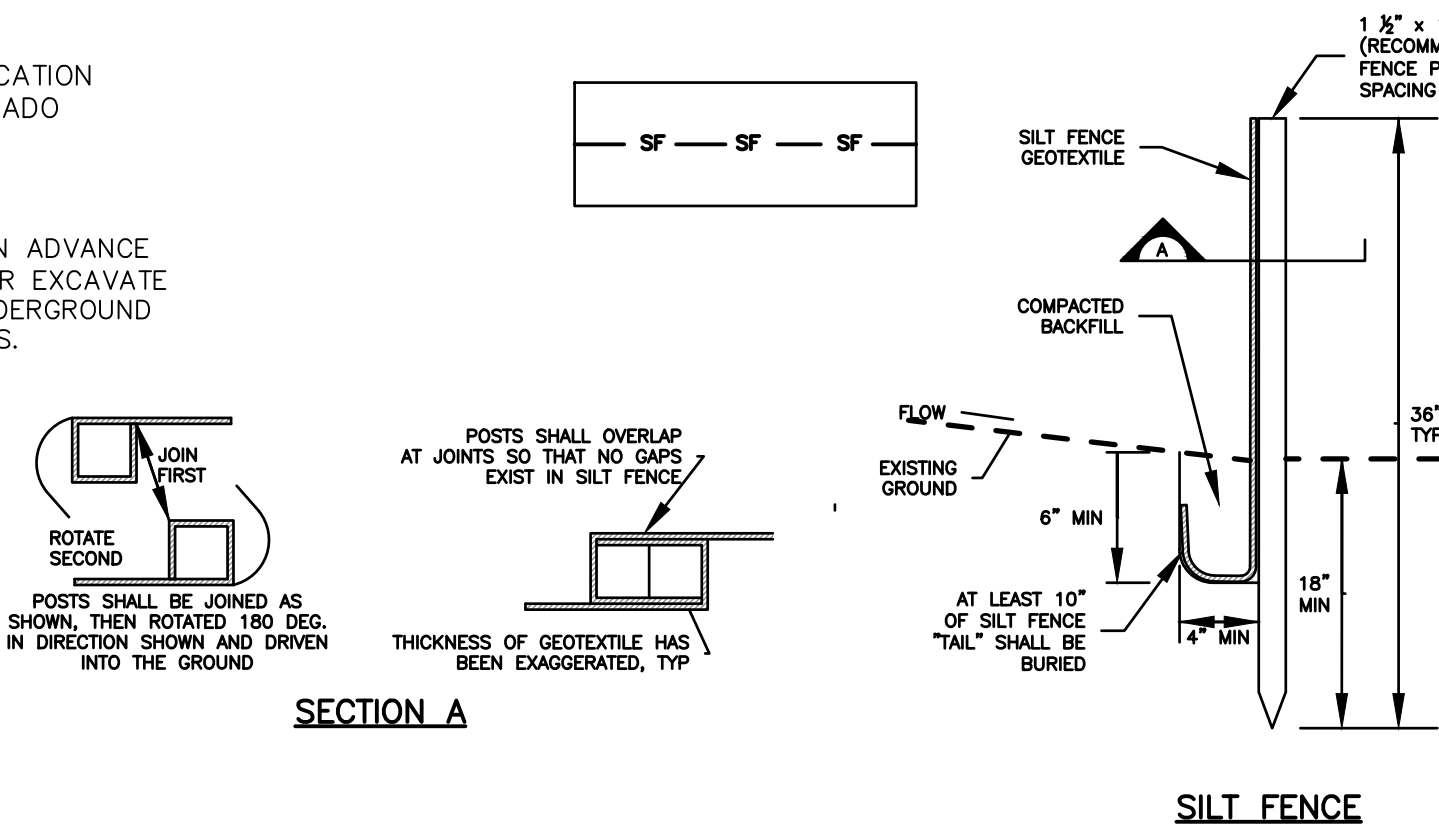
SILT FENCE INSTALLATION NOTES

1. SILT FENCE MUST BE PLACED AWAY FROM THE TOE OF THE SLOPE TO ALLOW FOR WATER PONDING. SILT FENCE AT THE TOE OF A SLOPE SHOULD BE INSTALLED IN A FLAT LOCATION AT LEAST SEVERAL FEET (2-5 FT) FROM THE TOE OF THE SLOPE TO ALLOW ROOM FOR PONDING AND DEPOSITION.

5. REPAIR OR REPLACE SILT FENCE WHEN THERE ARE SIGNS OF WEAR, SUCH AS SAGGING, TEARING, OR COLLAPSE.
6. SILT FENCE IS TO REMAIN IN PLACE UNTIL THE UPSTREAM DISTURBED AREA IS STABILIZED AND APPROVED BY THE LOCAL JURISDICTION, OR IS REPLACED BY AN EQUIVALENT PERIMETER SEDIMENT CONTROL MEASURE.

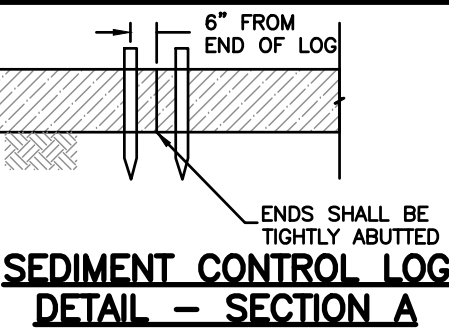
SEDIMENT CONTROL LOG
DETAIL - SECTION A

- ### SEDIMENT CONTROL LOG INSTALLATION NOTES
1. SEE PLAN VIEW FOR LOCATION AND LENGTH OF SEDIMENT CONTROL LOGS.
 2. SEDIMENT CONTROL LOGS THAT ACT AS A PERIMETER CONTROL SHALL BE INSTALLED PRIOR TO ANY UPGRADE/LAND-DISTURBING ACTIVITIES.

3. SEDIMENT CONTROL LOGS SHALL CONSIST OF STRAW, COMPOST, EXCLOSIOR OR COCONUT FIBER, AND SHALL BE FREE OF ANY NOXIOUS WEED SEEDS OR DEFECTS INCLUDING RIPS.

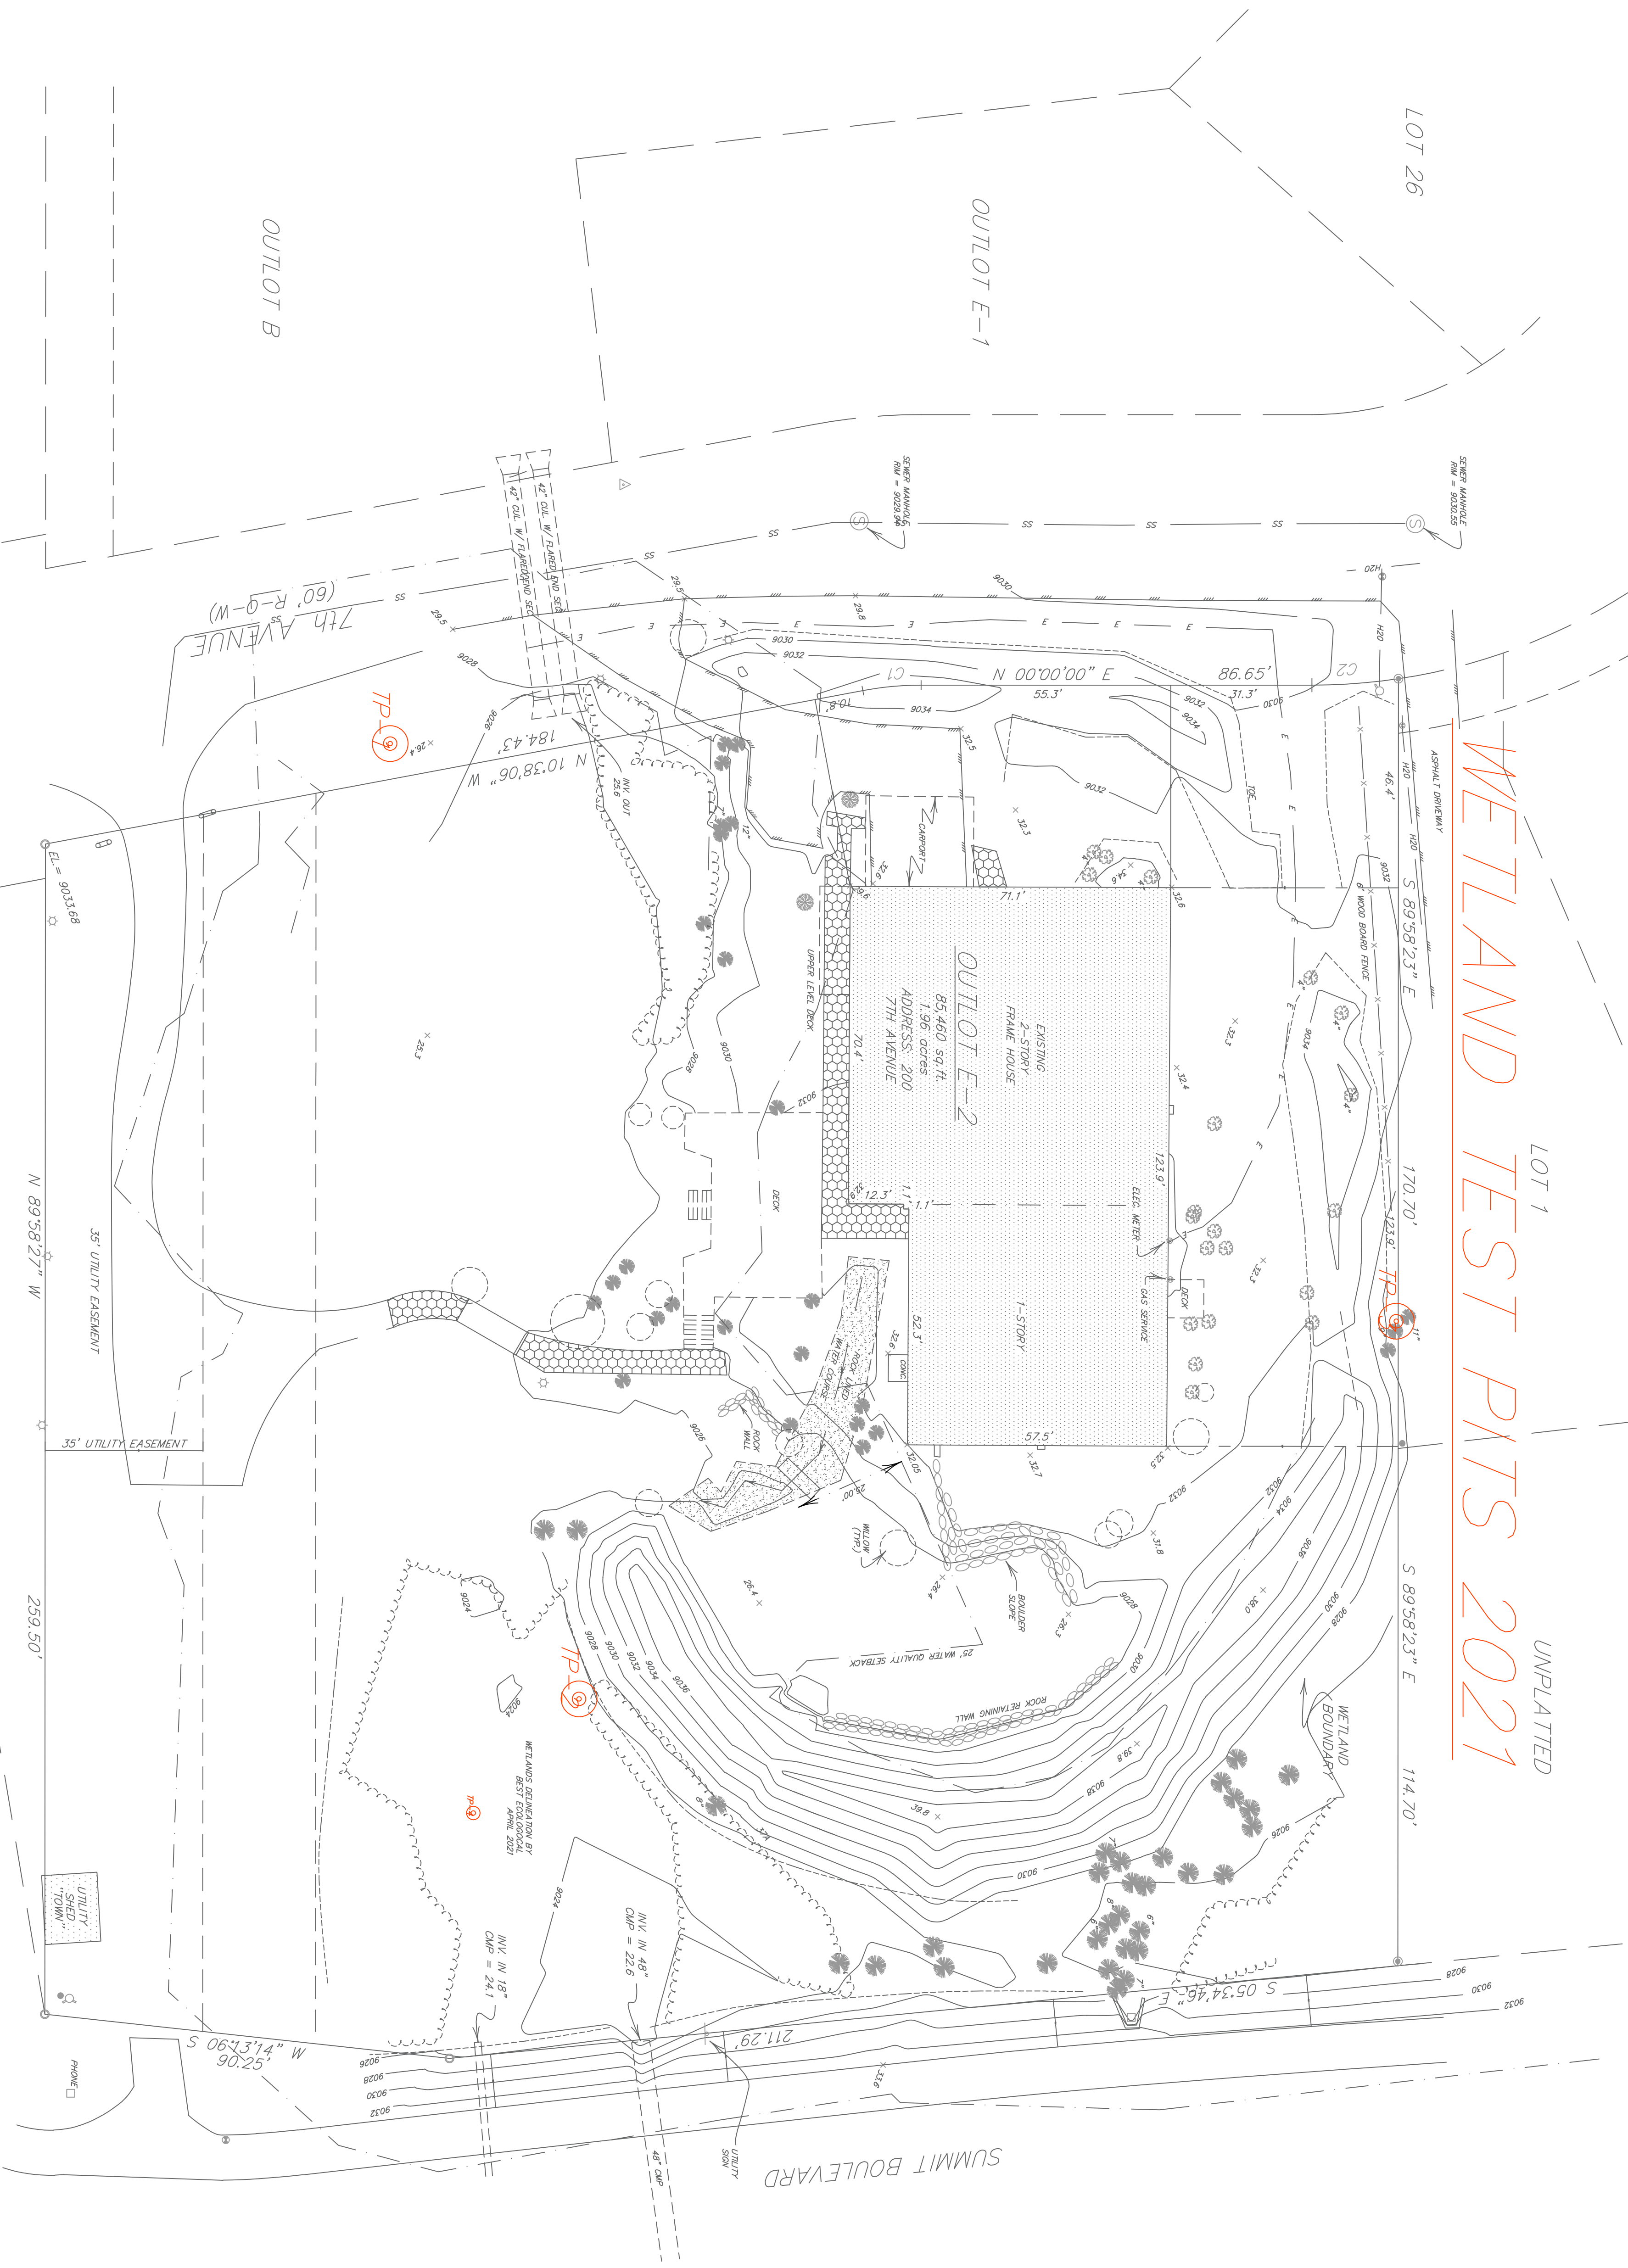
A TOPOGRAPHIC MAP OF A PORTION OF
OUTLOT E-2, REPLAT A, RIVER PINES SUBDIVISION
ACCORDING TO THE PLAT RECORDED OCT. 17, 1991 AT REC. NO. 411259
TOWN OF FRISCO, SUMMIT COUNTY, COLORADO

LOT 1
UNPLATTED
WETLAND TEST PITS 2021

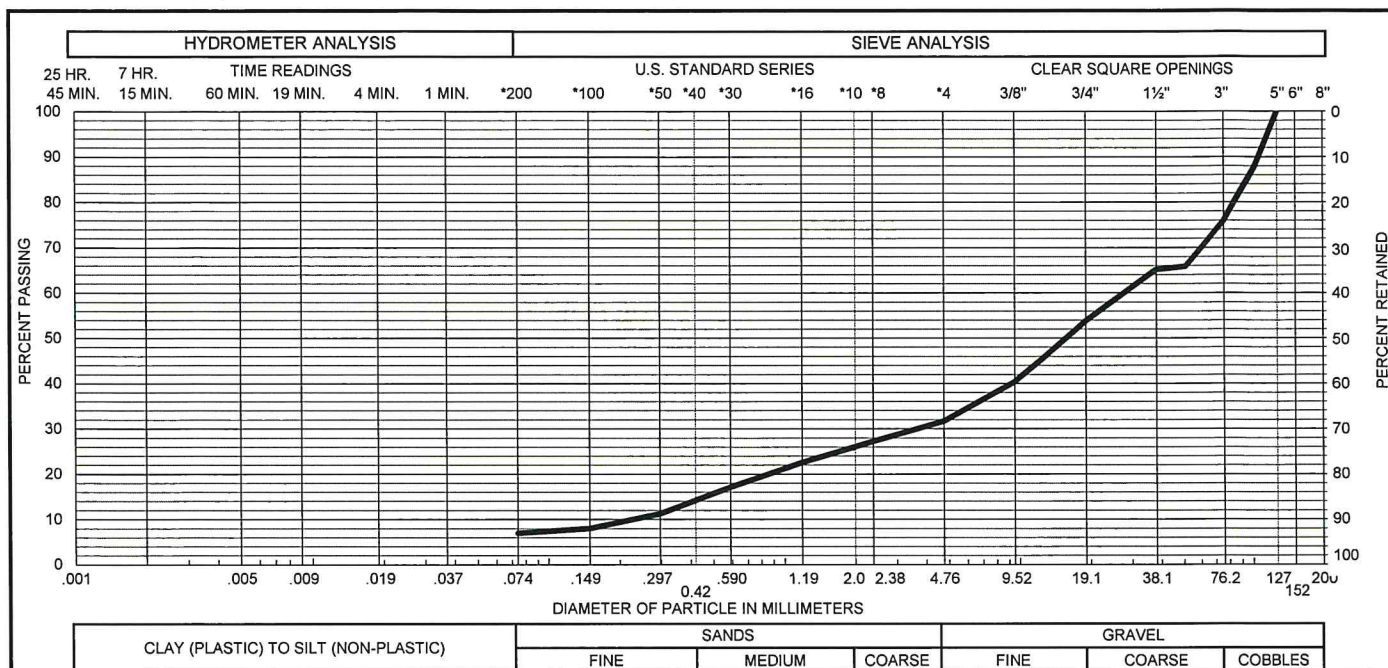
Figure 4

Sieve Size	% Passing
4 in.	88
3 in.	76
2 in.	66
1.5 in.	65
3/4 in.	54
1/2 in.	46
3/8 in.	40
No. 4	32
No. 8	27
No. 16	23
No. 30	17
No. 50	11
No. 100	8
No. 200	7

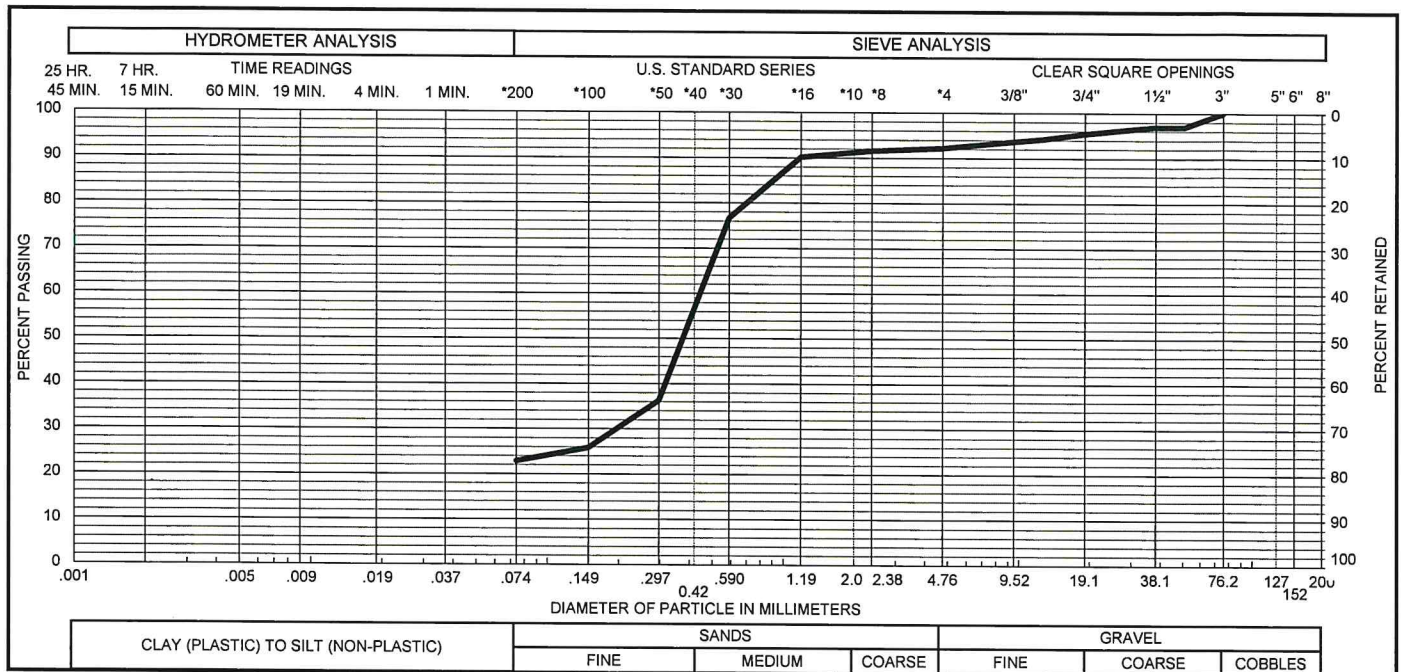
Figure 5

Sieve Size	% Passing
3 in.	100
2 in.	97
1.5 in.	97
3/4 in.	95
1/2 in.	94
3/8 in.	94
No. 4	92
No. 8	92
No. 16	90
No. 30	77
No. 50	36
No. 100	26
No. 200	23

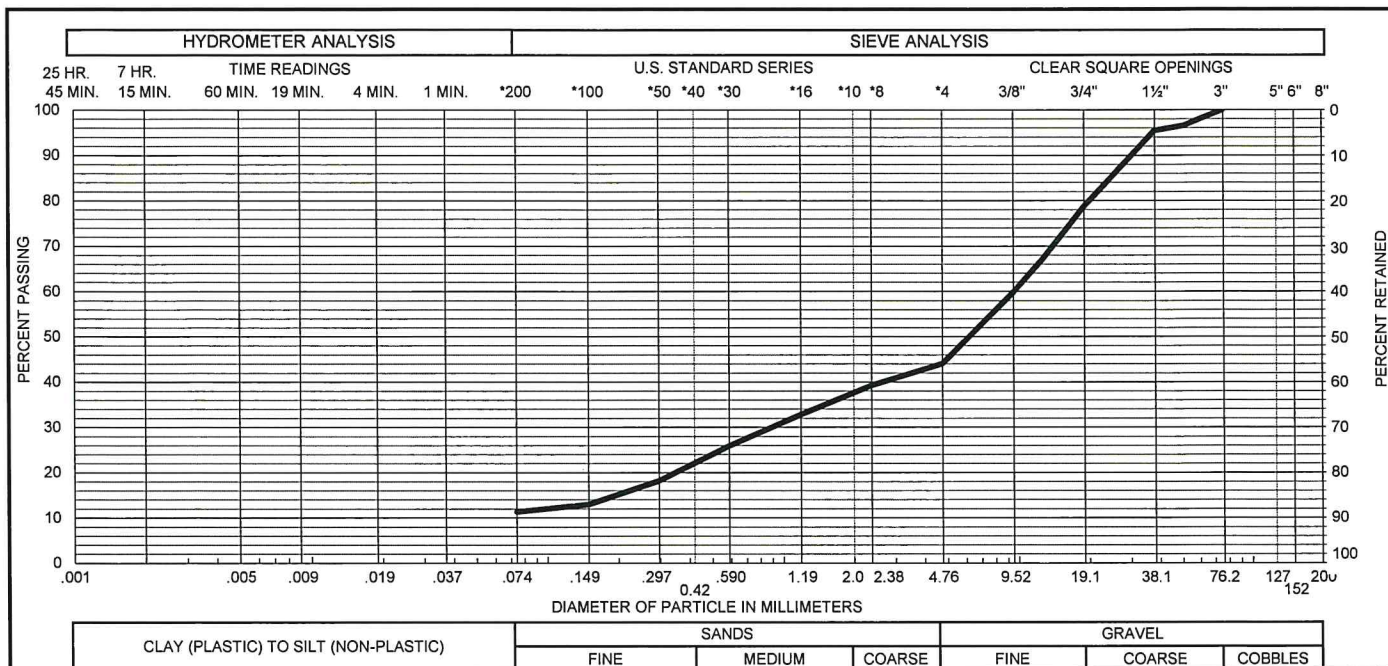
Figure 6

Sieve Size	% Passing
3 in.	100
2 in.	97
1.5 in.	95
3/4 in.	79
1/2 in.	67
3/8 in.	60
No. 4	44
No. 8	39
No. 16	33
No. 30	26
No. 50	18
No. 100	13
No. 200	11

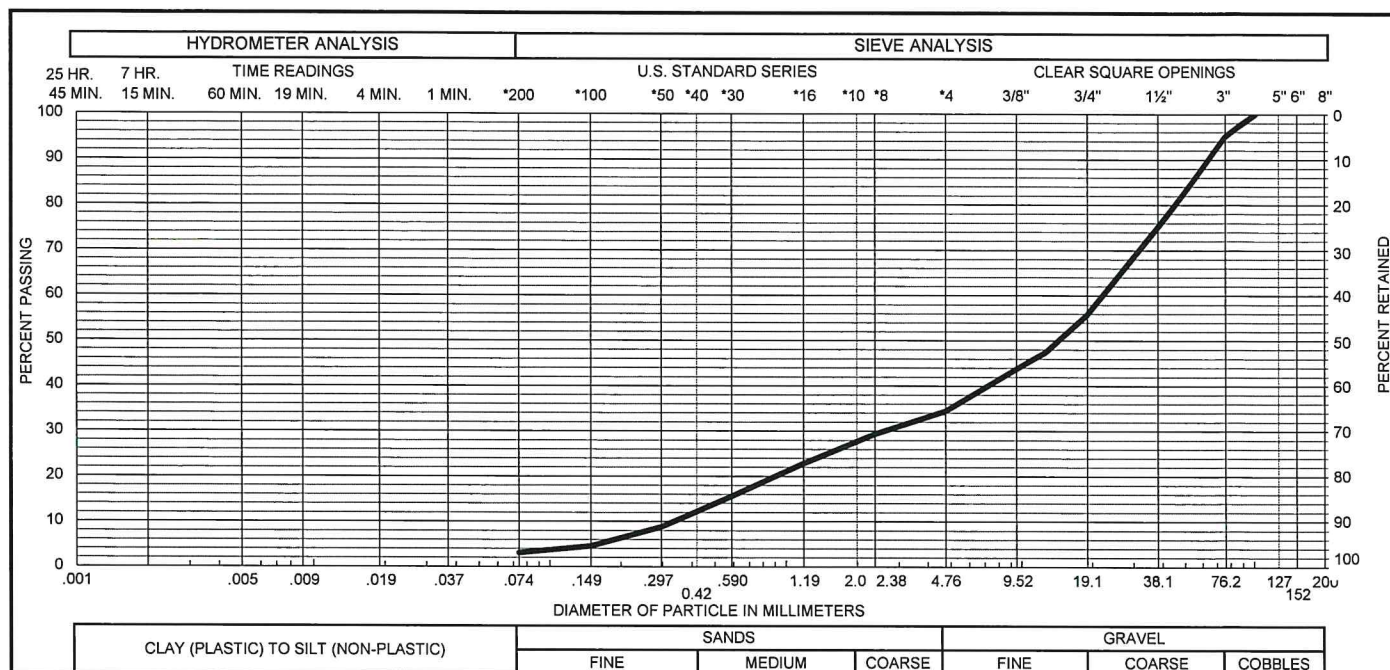
Figure 7

Sieve Size	% Passing
4 in.	100
3 in.	95
2 in.	84
1.5 in.	75
3/4 in.	56
1/2 in.	47
3/8 in.	44
No. 4	34
No. 8	29
No. 16	23
No. 30	16
No. 50	9
No. 100	5
No. 200	3

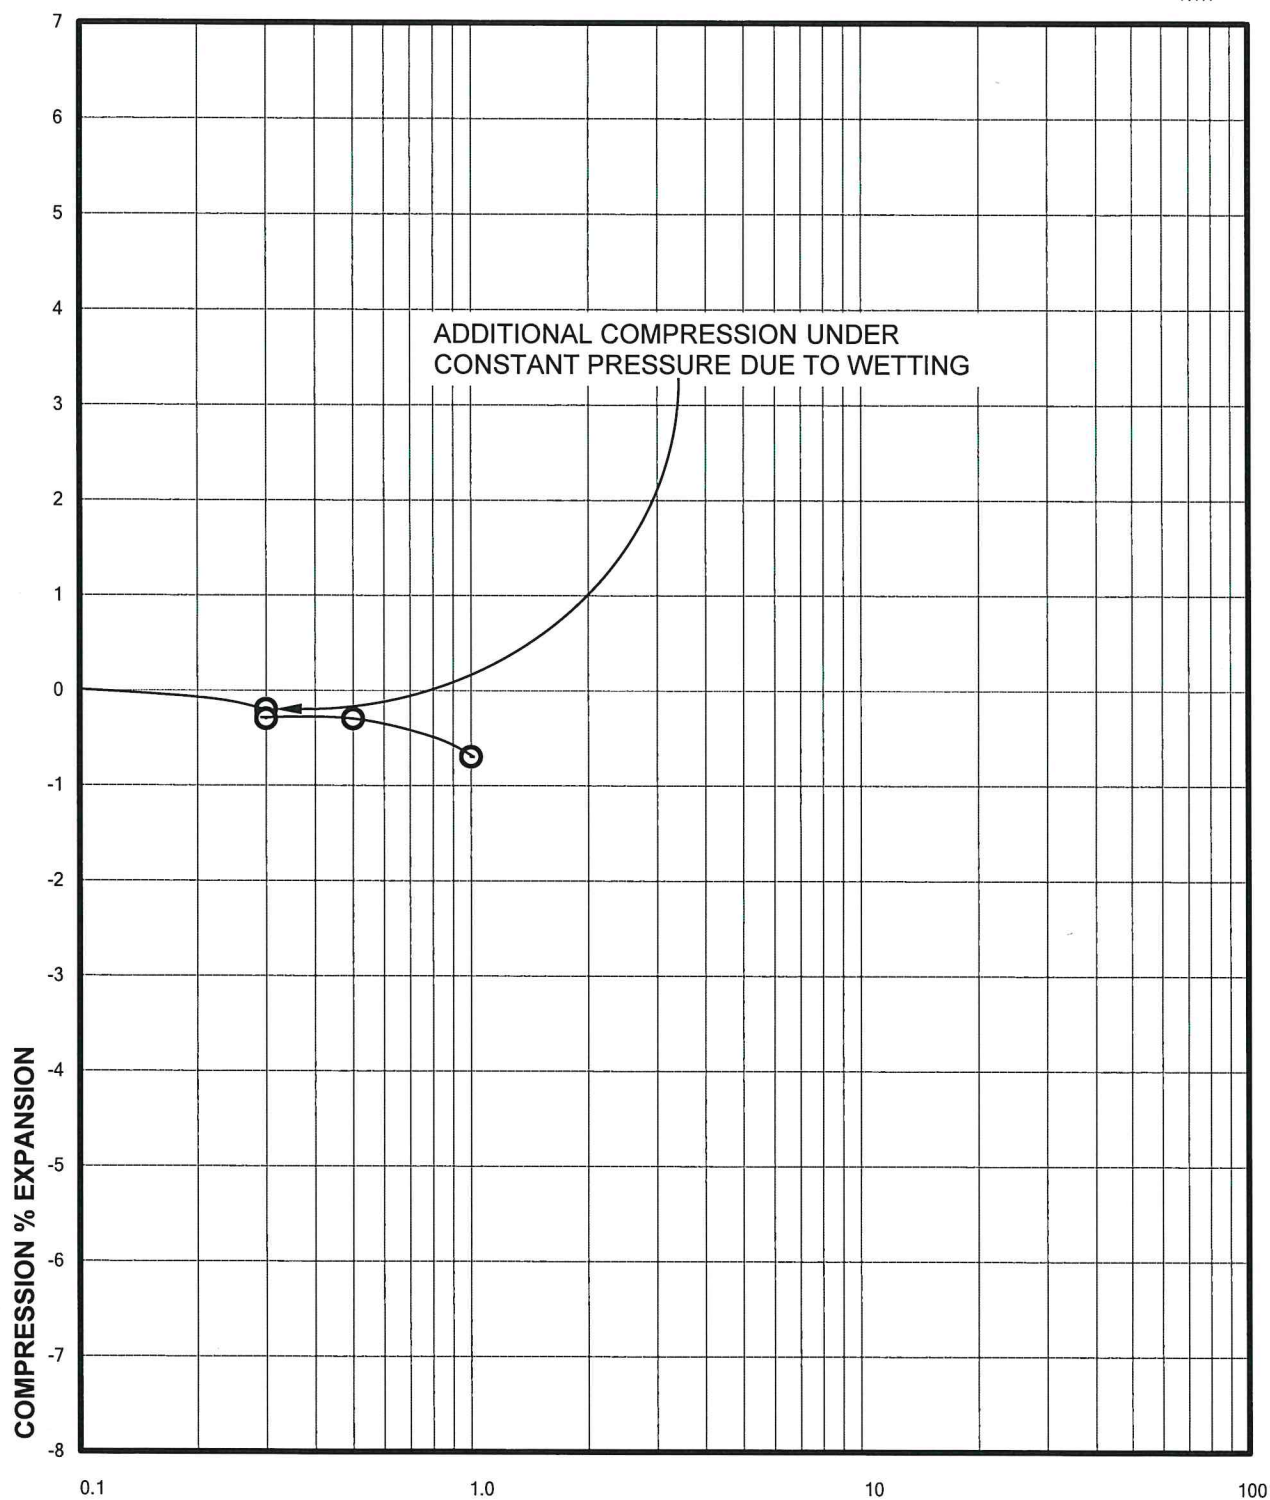
APPLIED PRESSURE - KSF
Sample of Silt with Sand (ML)
From TP-3 @ 20"

DRY UNIT WEIGHT= 81 PCF
MOISTURE CONTENT= 35.5 %

Swell Consolidation Test Results

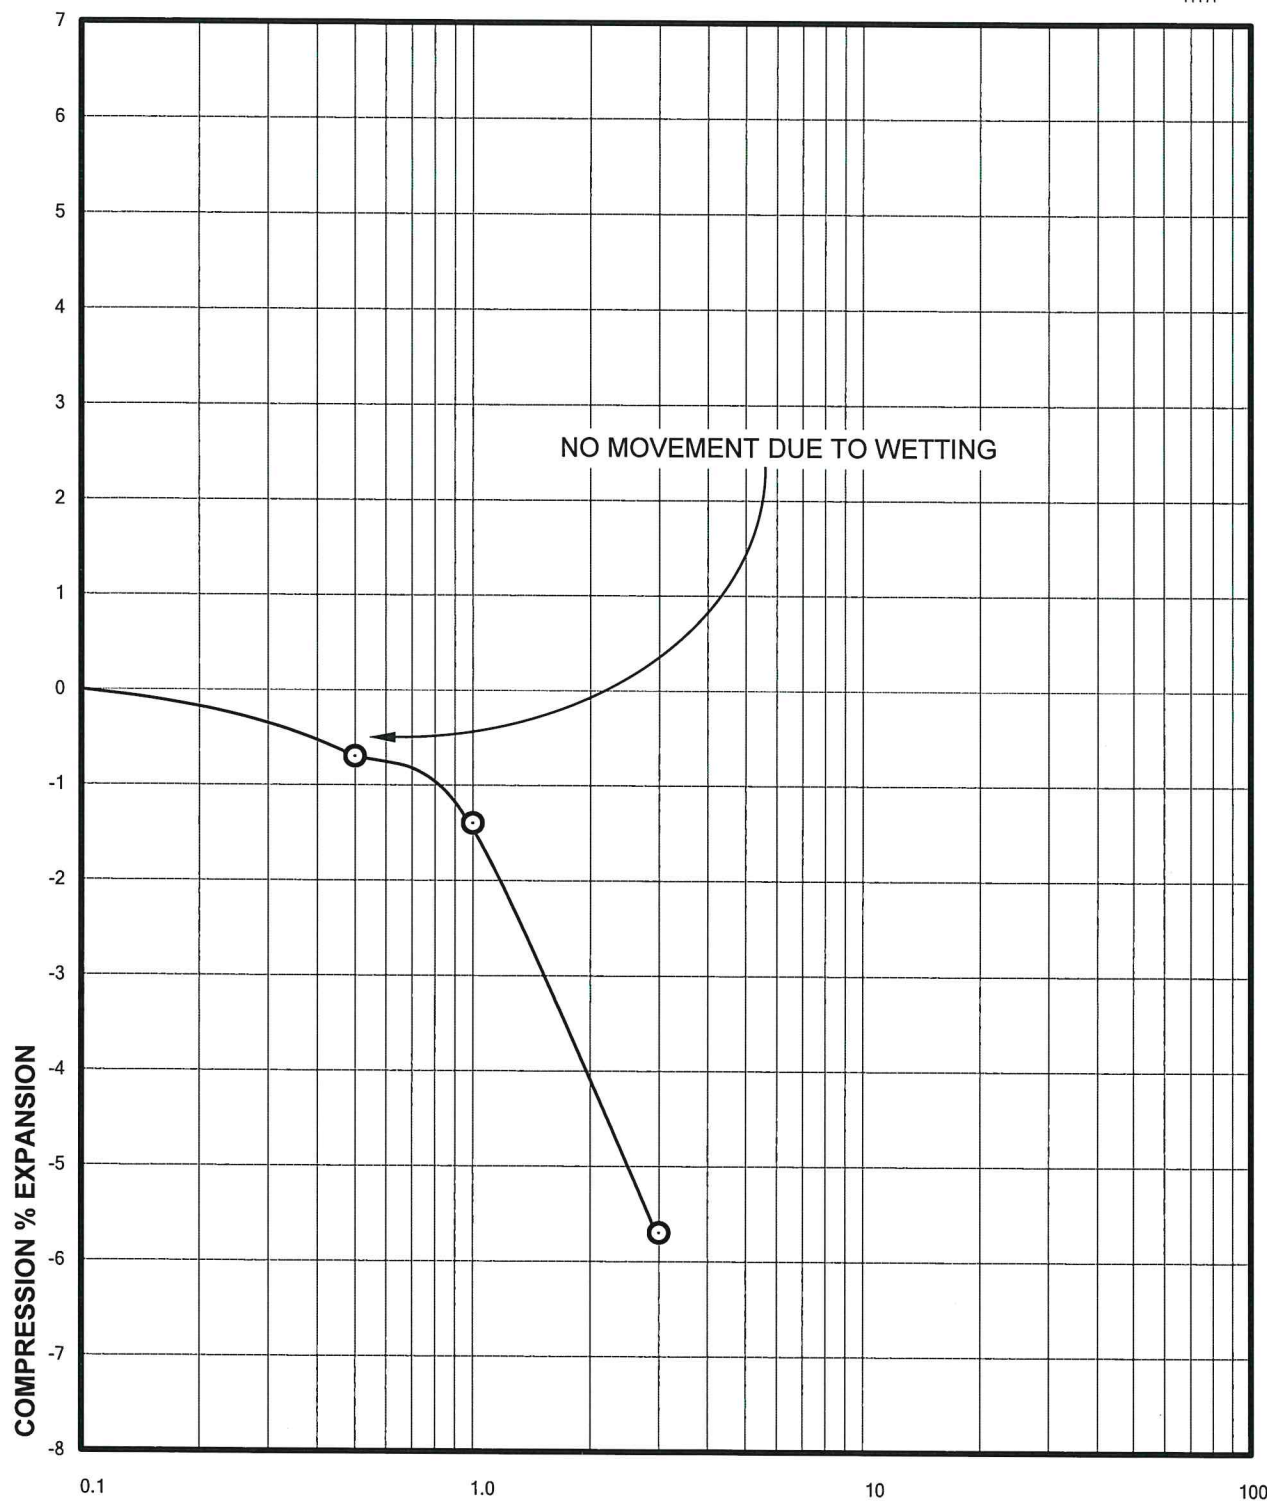
APPLIED PRESSURE - KSF
Sample of Silty Sand (SM)
From TP-6 @ 3'6"

DRY UNIT WEIGHT= 82 PCF
MOISTURE CONTENT= 20.5 %

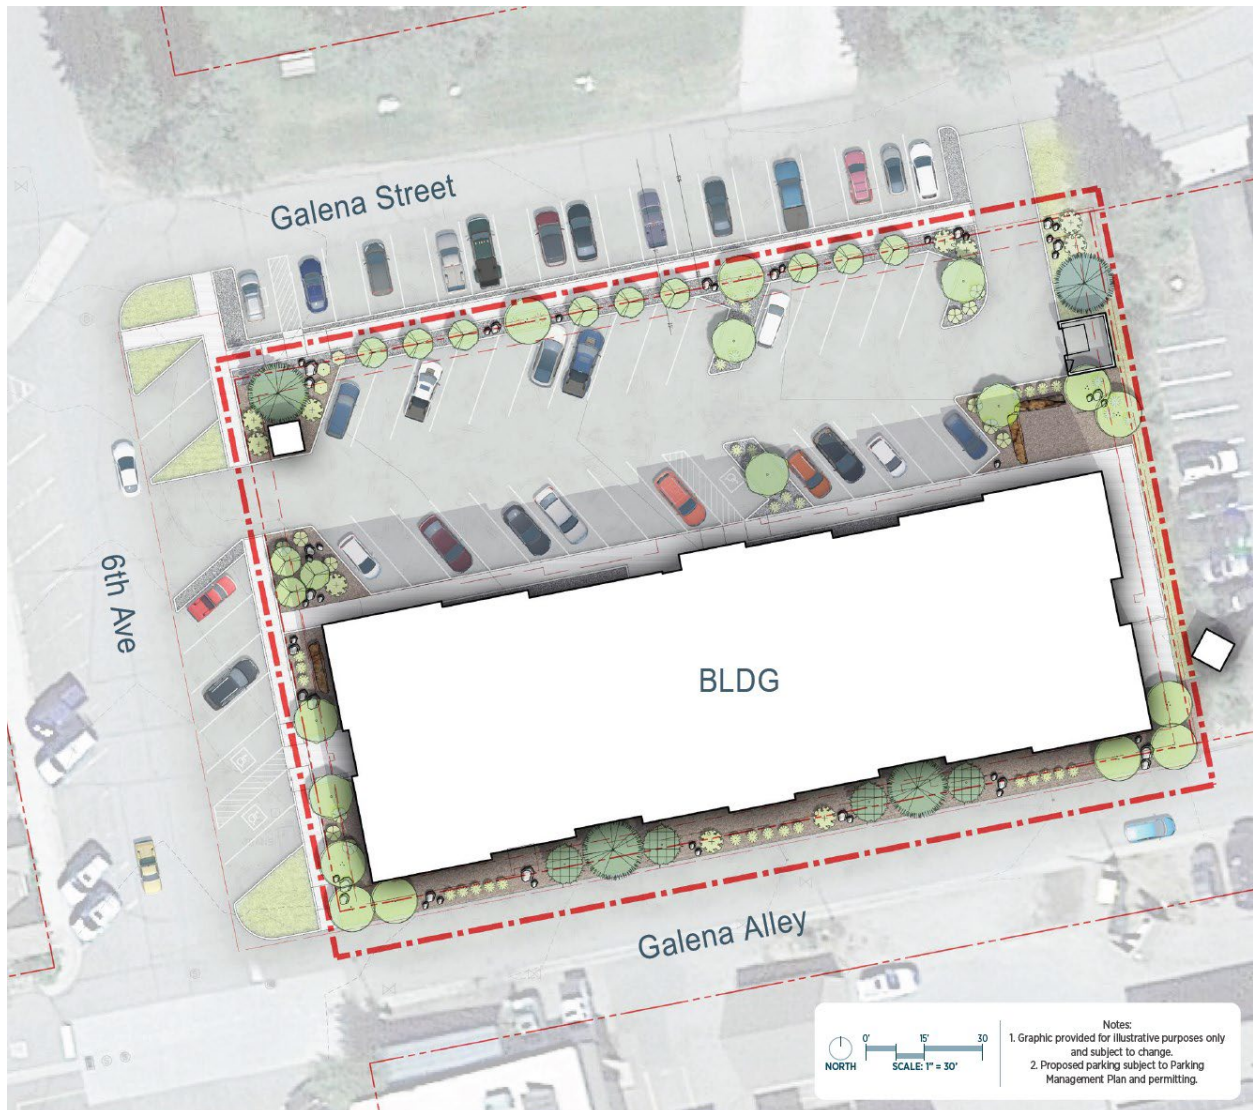
Figure 1: Site Plan

The project site currently has two accesses located on the north and west side of the parcel. One access has direct connectivity to Galena Street and the other to 6th Ave. The proposed site plan is shown in **Figure 1**.

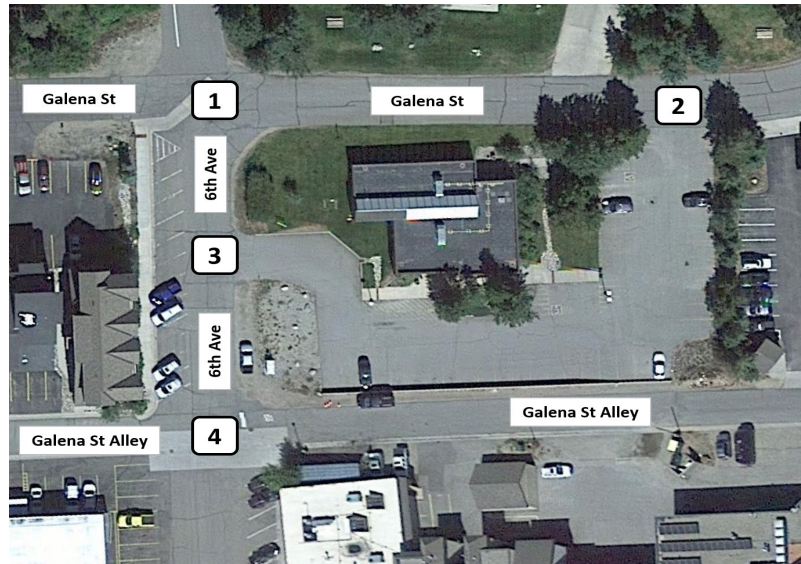
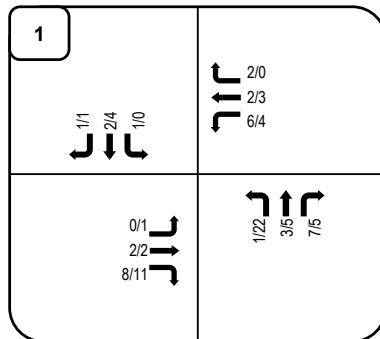
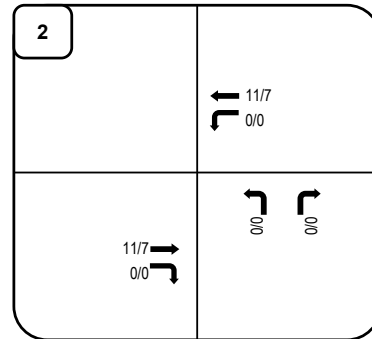
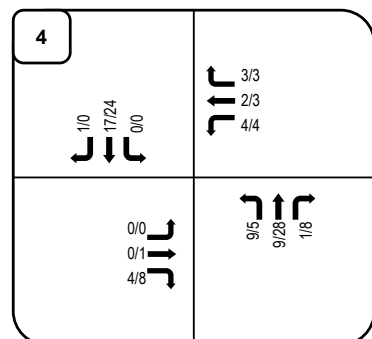
Figure 3: Year 2023 Seasonally Adjusted Existing Traffic

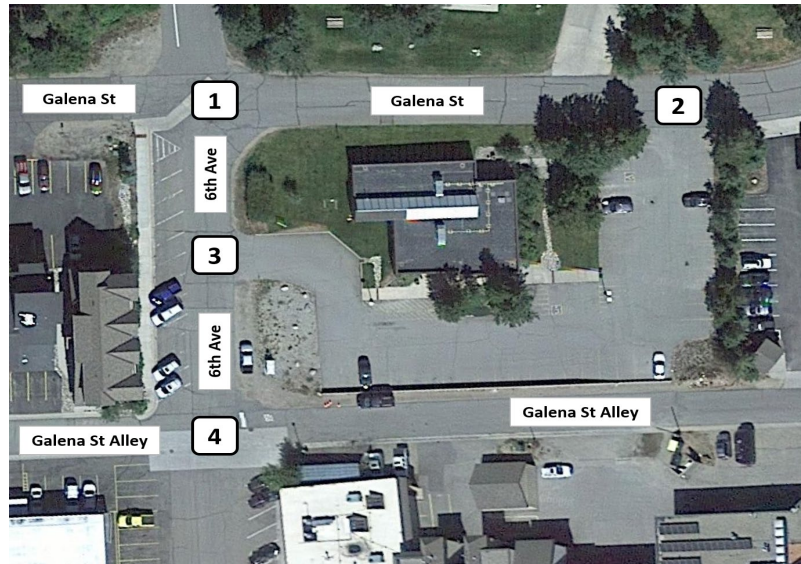
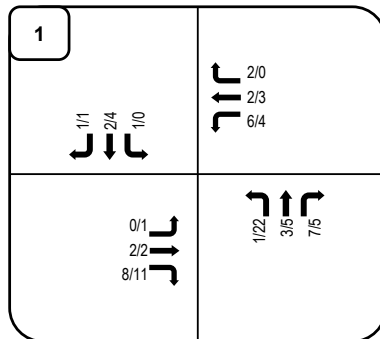
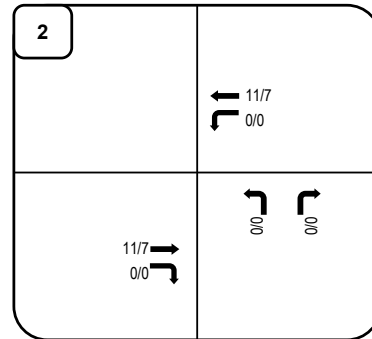
Figure 4: Year 2024 Background Traffic

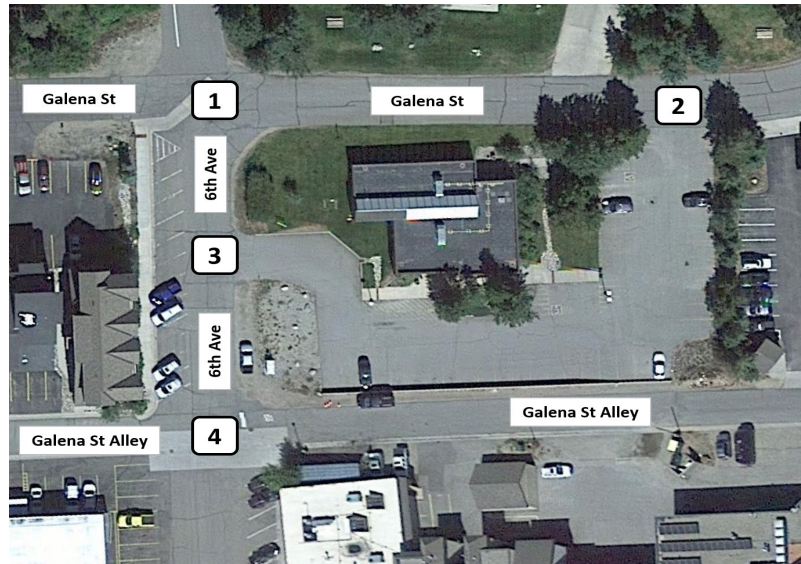
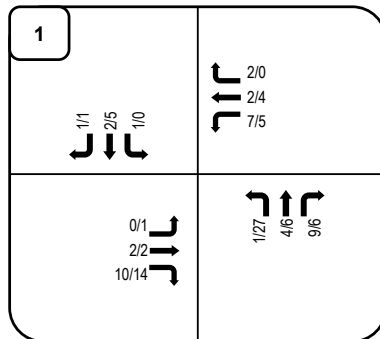
Figure 5: Year 2045 Background Traffic

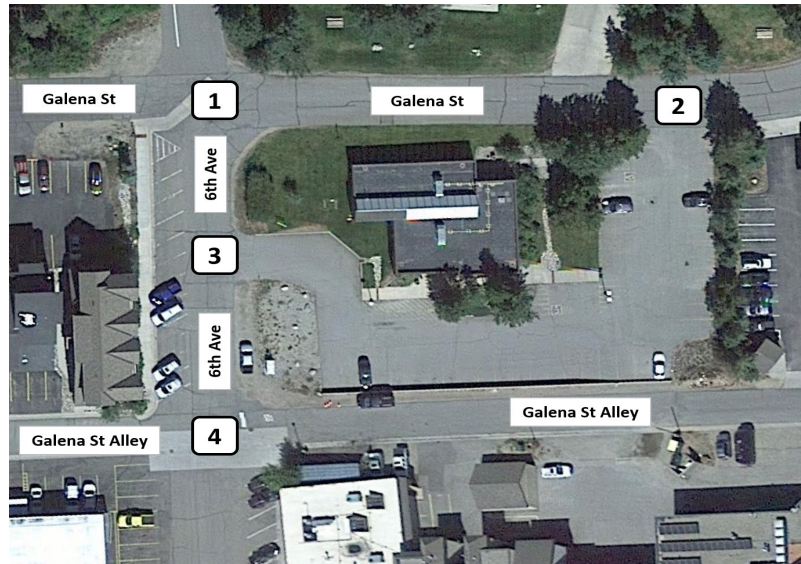
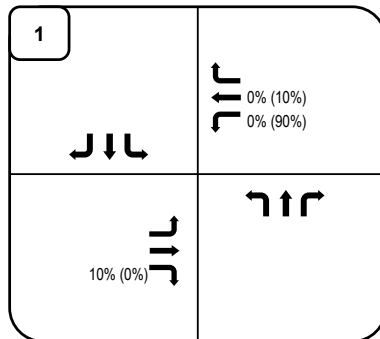
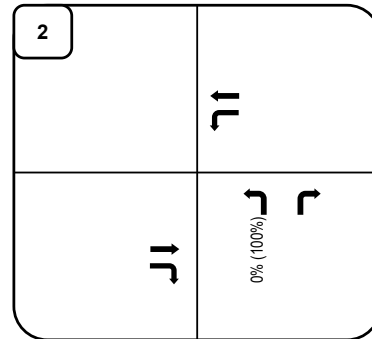
Figure 6: Project Generated Traffic Distribution (602 Galena St)

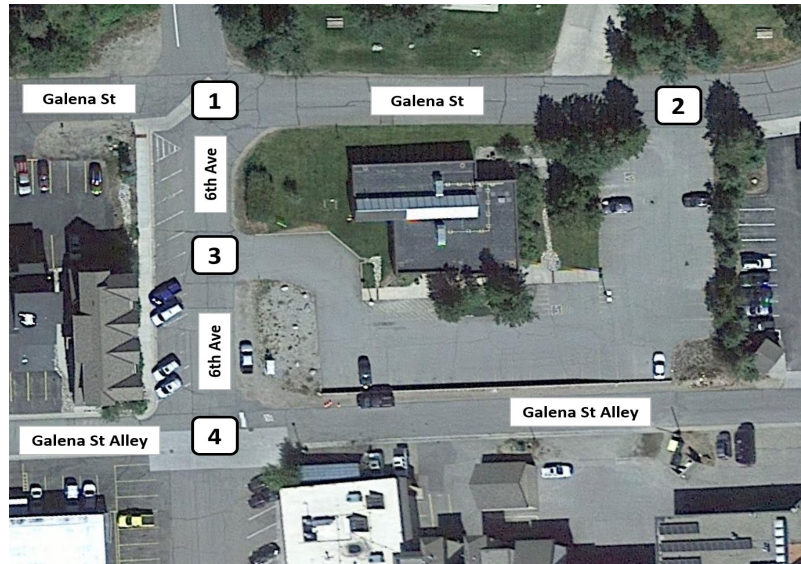
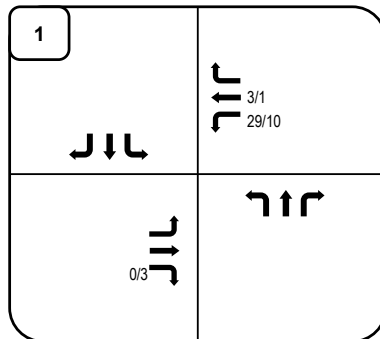
Figure 7: Project Generated Traffic Assignment (602 Galena St)

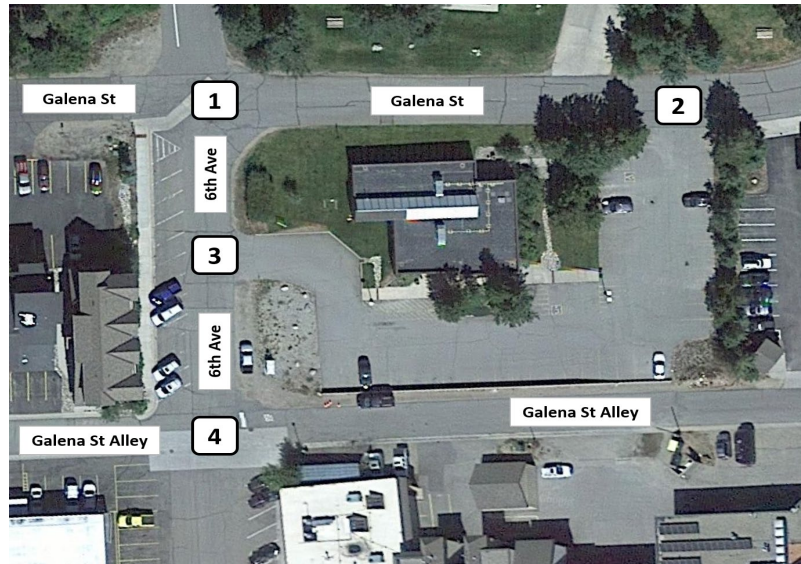
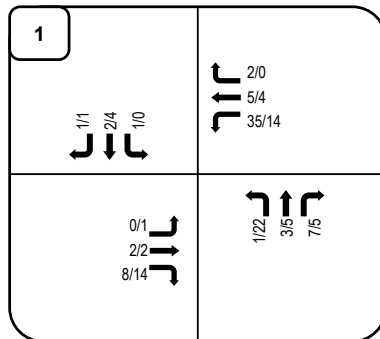
Figure 8: Year 2024 Total Traffic

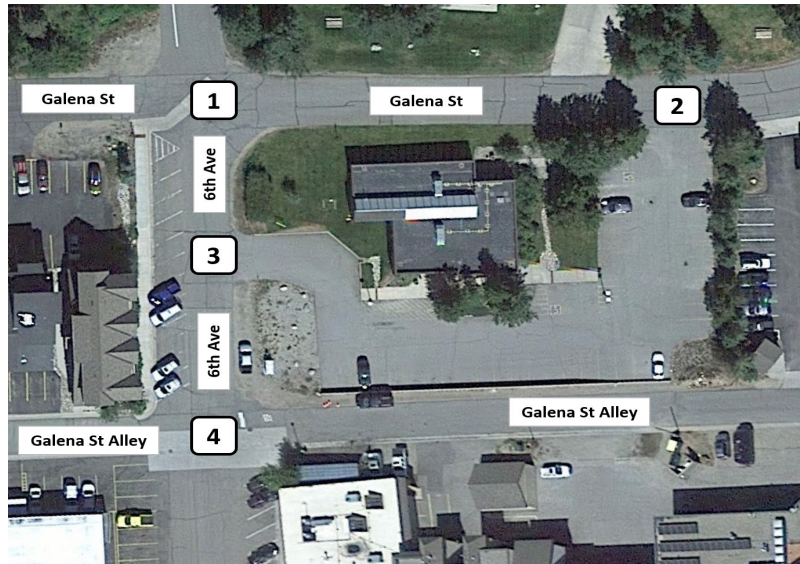
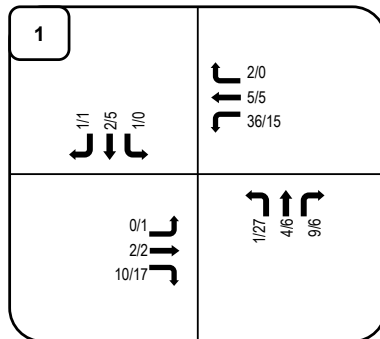
Figure 9: Year 2045 Total Traffic
